Scenic Stewardship:

A Plan to Preserve and Enhance the Landscape
of the Brandywine Valley Scenic Byway

Regional Landscape Enhancement
Susan Barton
Rick Darke
Gary Schwetz
For Delaware Greenways

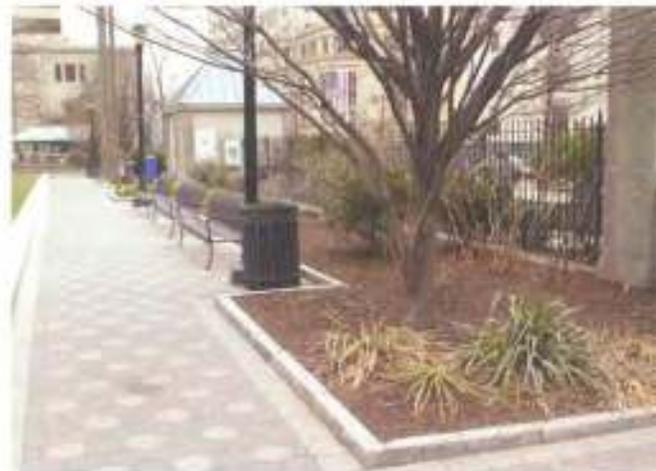
Plate 005 Rodney Square, winter 2003

The City Beautiful Movement in the early 1900's promoted public open space. Inspired by this movement, the New Castle County Courthouse of 1880 was demolished and the new City/County Courthouse was positioned east of King Street providing the opportunity to create the open space that is now Rodney Square. Rodney Square was originally conceived as a central rectangular lawn bordered by symmetric flowerbeds. Double rows of trees were planted around the periphery in turf beds (Plate 004). The labor-intensive flowerbeds were discarded late in the 20th century in favor of naturalistic beds using native plants. As replacements have been made to meet the demands of garden culture and human use, the result has been a greater diversity of plants. The naturalistic design and increased diversity is at odds with the traditionally ordered symmetry of the park (Plate 005). This symmetry has been further degraded by the random loss of trees and shrubs through natural attrition and unhealthy conditions.

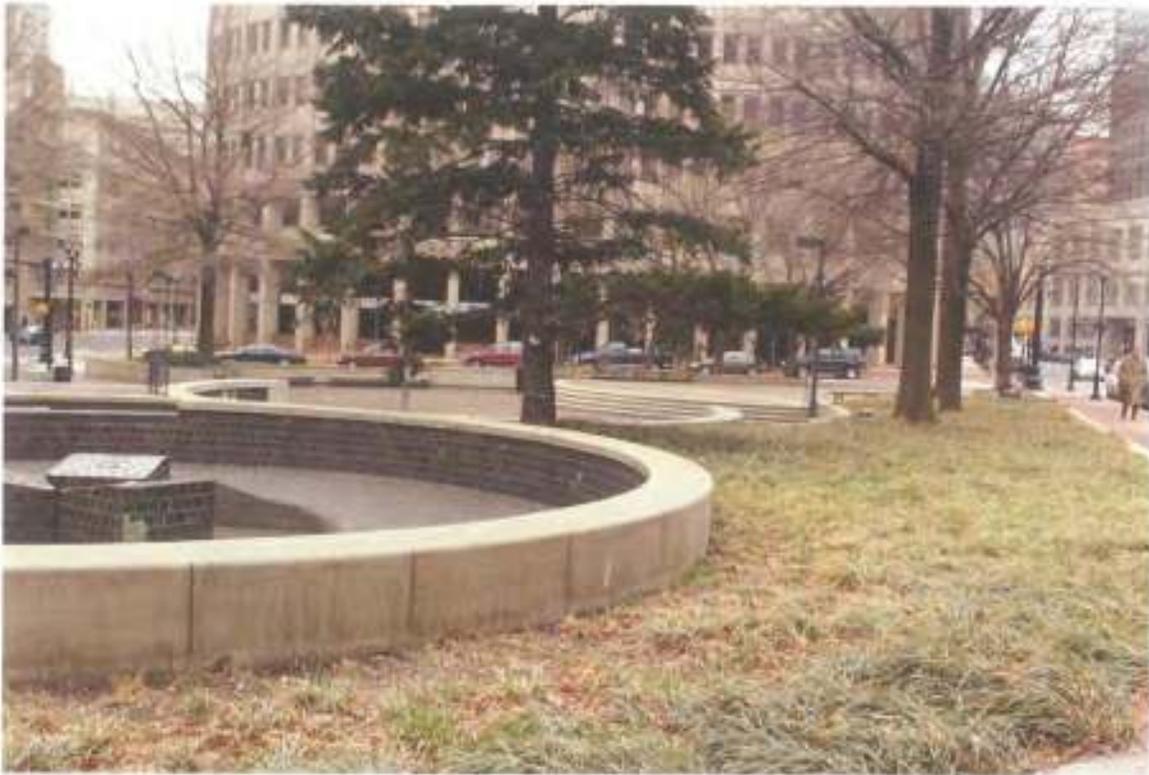
Plate 014 Planting opportunity around H. B. du Pont Plaza fountains

- Improve plantings in H.B. du Pont Plaza on 10th street by adding flowering interest with planted containers or by planting a row of shrubs (such as *Spirea* 'Snowmound') around the circular fountain (Plate 014).

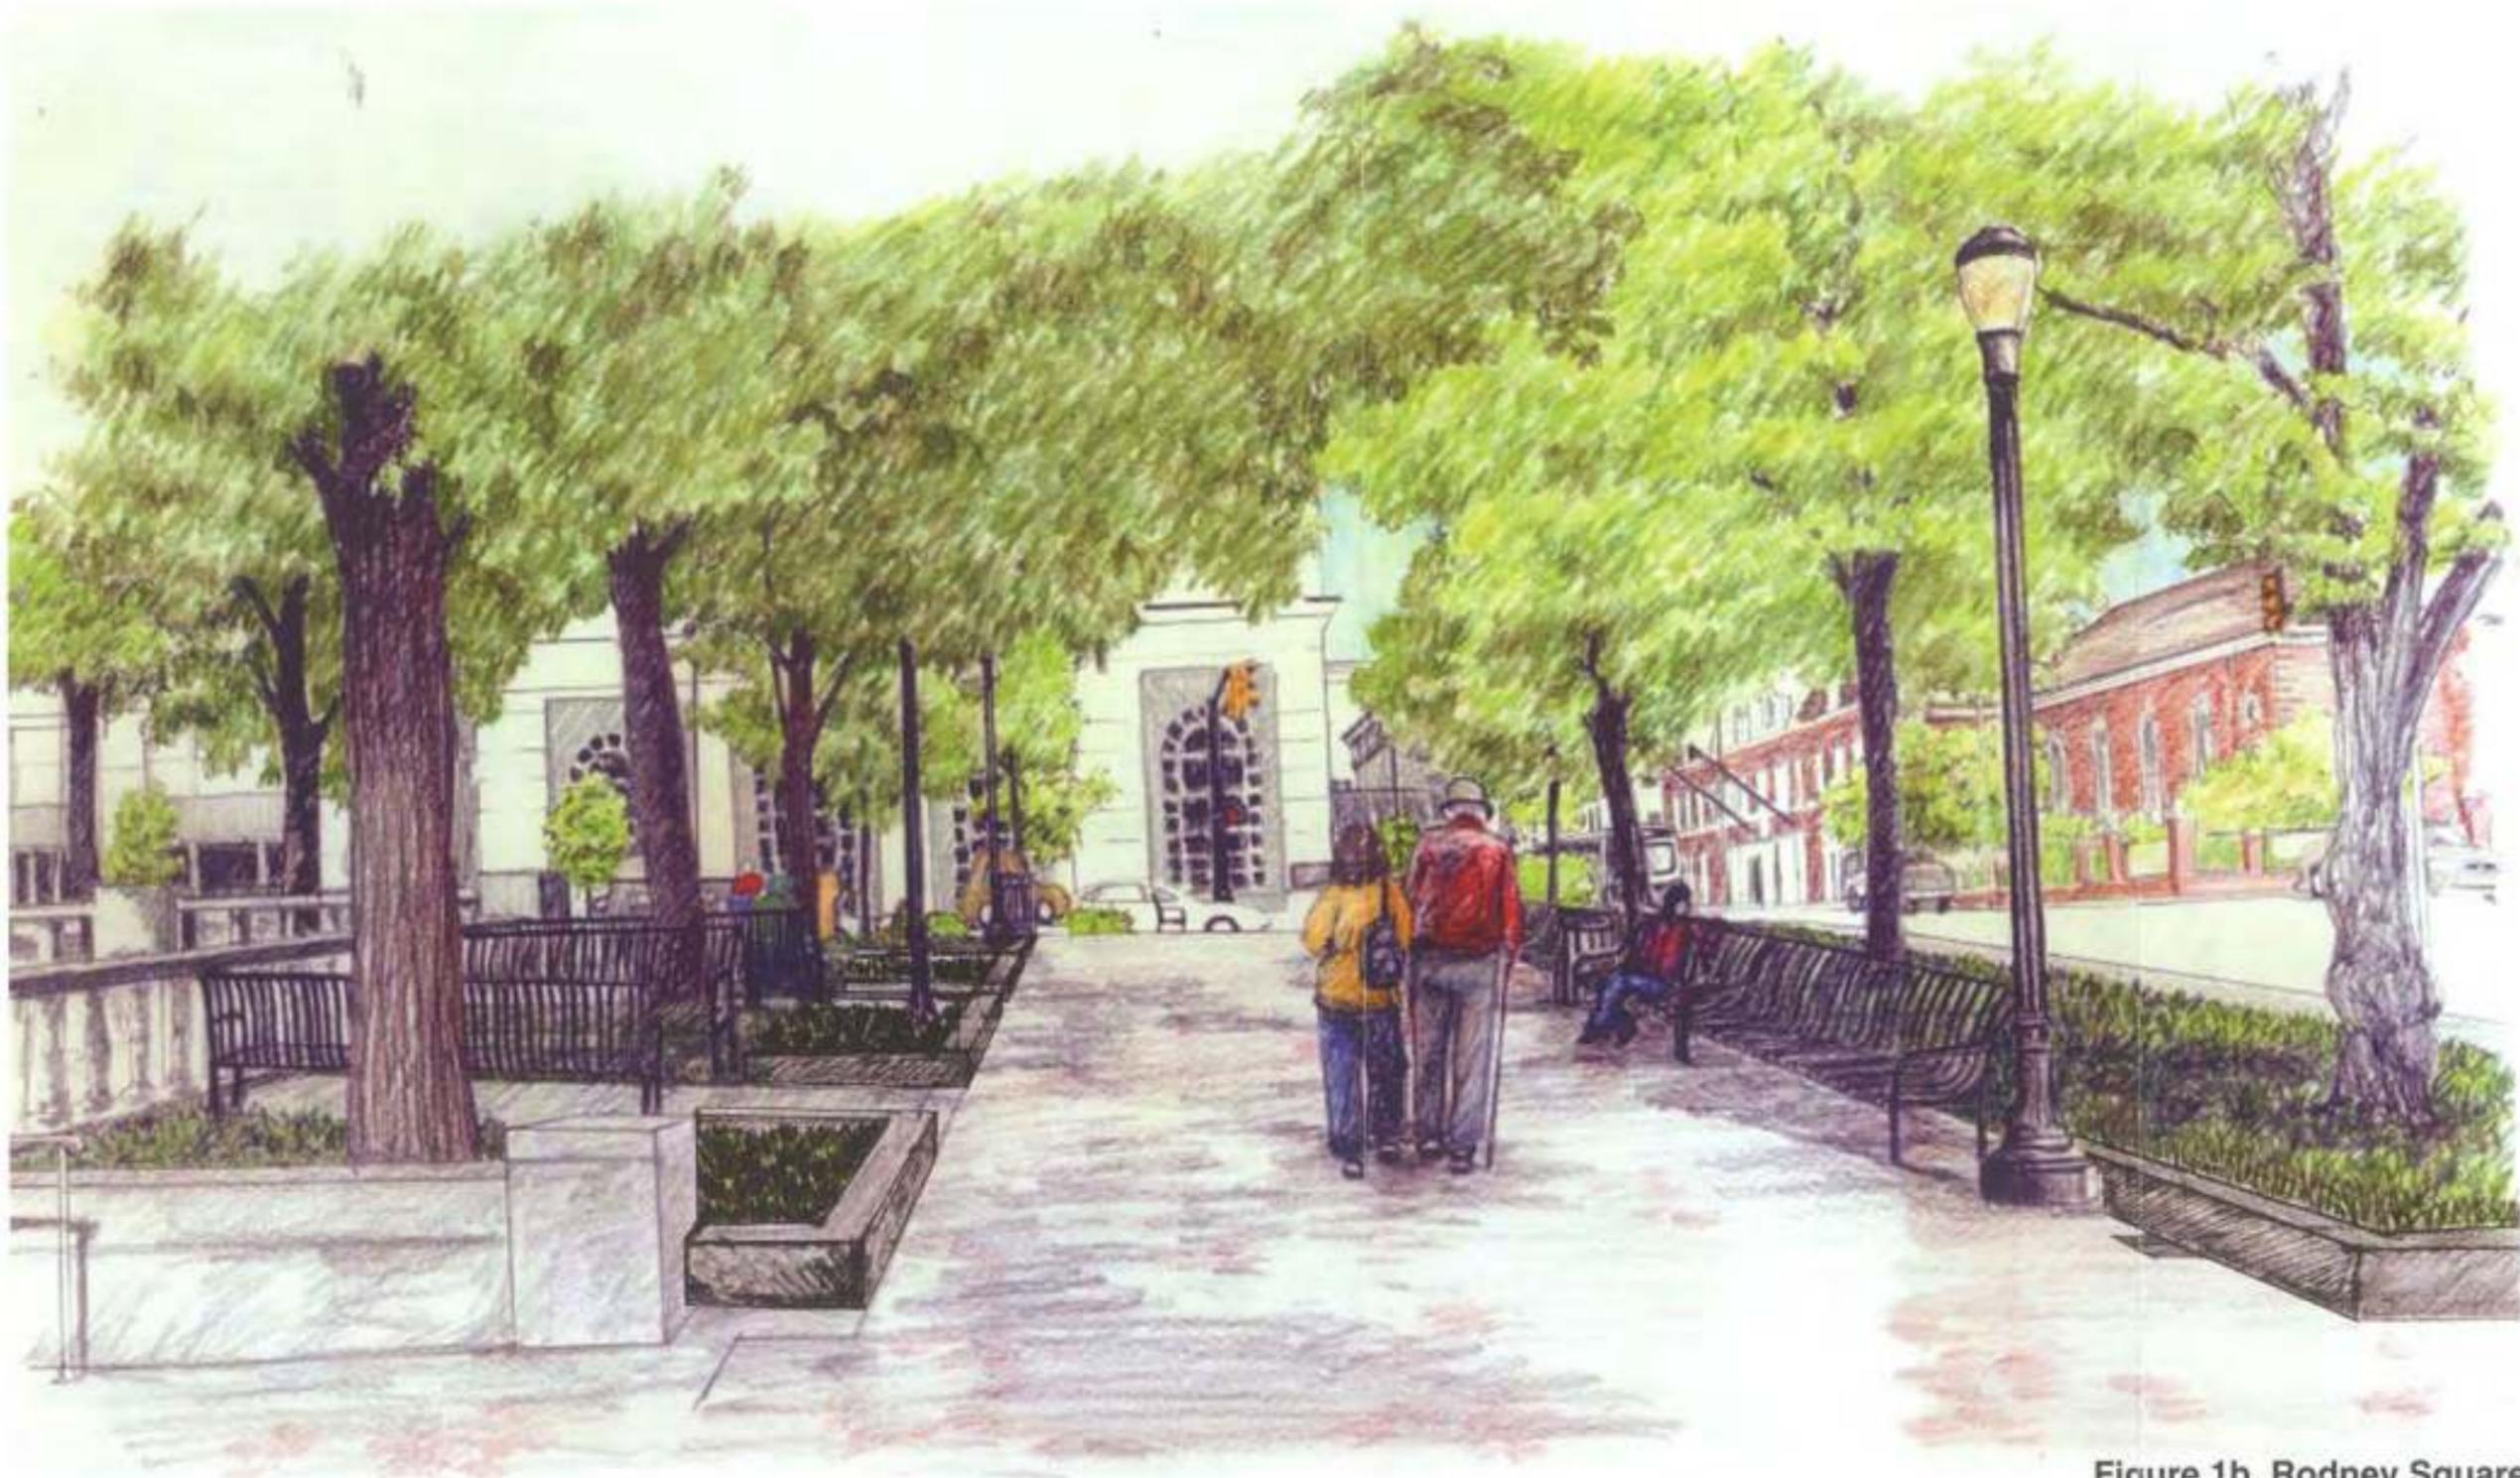
Figure 1b. Rodney Square

Perspective illustrating removal of pavers at trees
and replacement with *Carex sp.* groundcovers

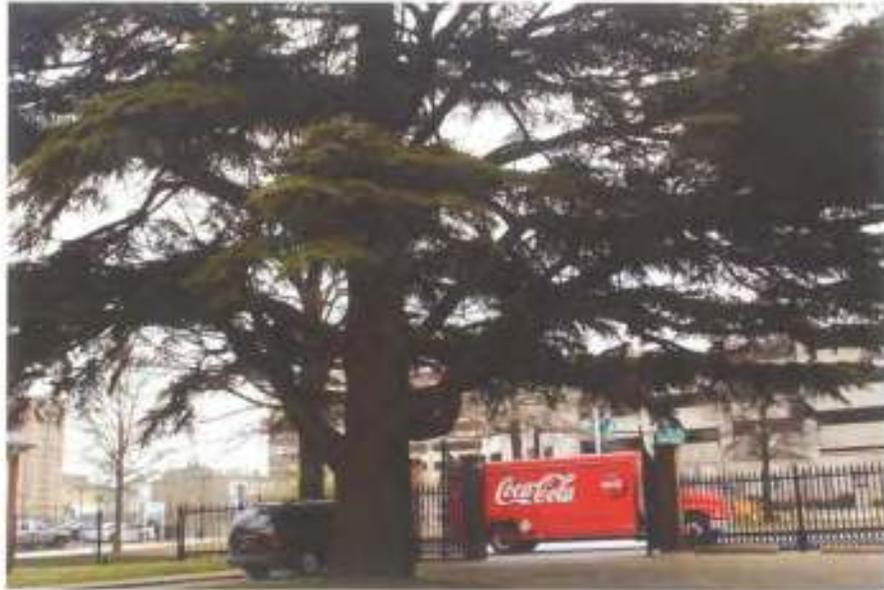
Plate 018. Same Cedar of Lebanon, 2004

them as valuable resources and should play an active role in their stewardship. This may mean providing assistance for their maintenance and replacement (Plate 018).

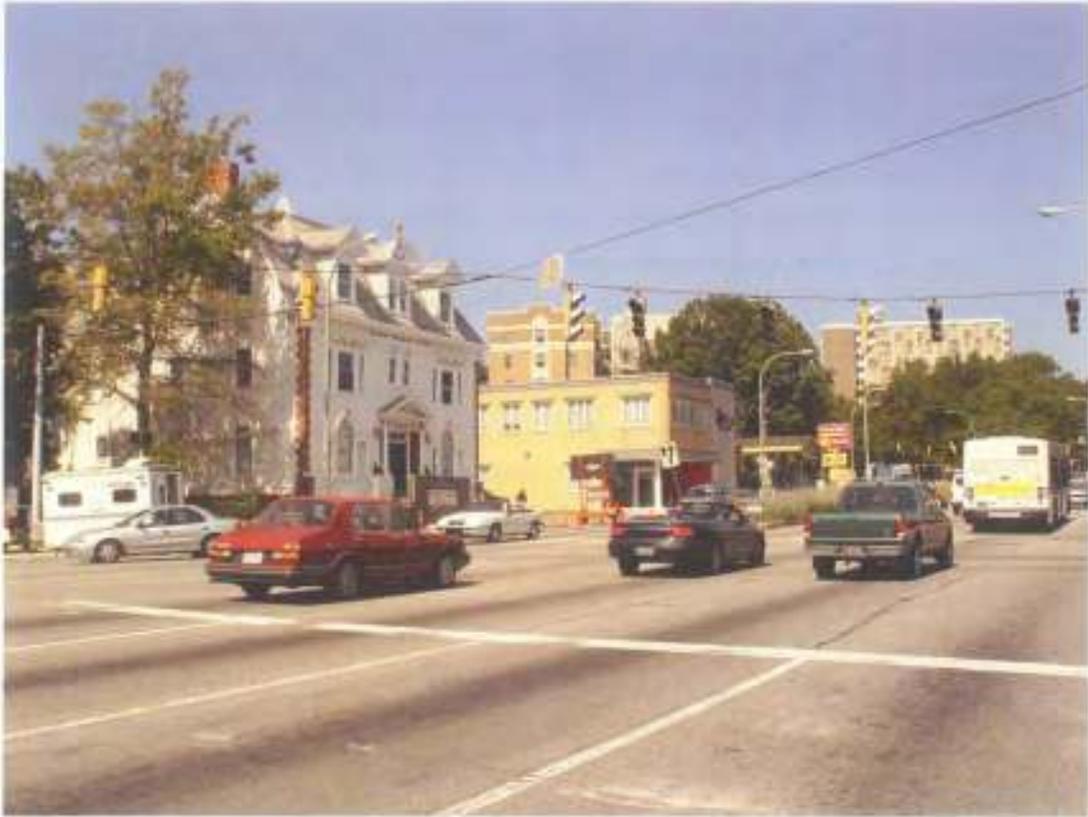
Plate 019 Delaware Avenue Intersection at Children's Theater

Delaware Children's Theatre is an example of existing open space housing trees that are critical to the tree canopy of Delaware. This intersection of Jackson Street and Delaware Avenue is an extreme example of the conflict between vehicular and pedestrian traffic (Plate 019). Patrons of the Delaware Children's Theatre must park on the north side of Delaware Avenue and cross Delaware Avenue—an unfriendly environment for pedestrians—to enter the theatre.

- Use crosswalks, landscaped medians and other traffic calming devices to create a pedestrian-friendly, aesthetically enhanced environment.
- Solutions for pedestrian safety and traffic calming currently included in the Delaware Children's Theatre portion of the Delaware Avenue Gateway Initiative proposal should be expanded to include green space improvements as illustrated in Figures 6 and 7 and given high priority as a Transportation Enhancement project.

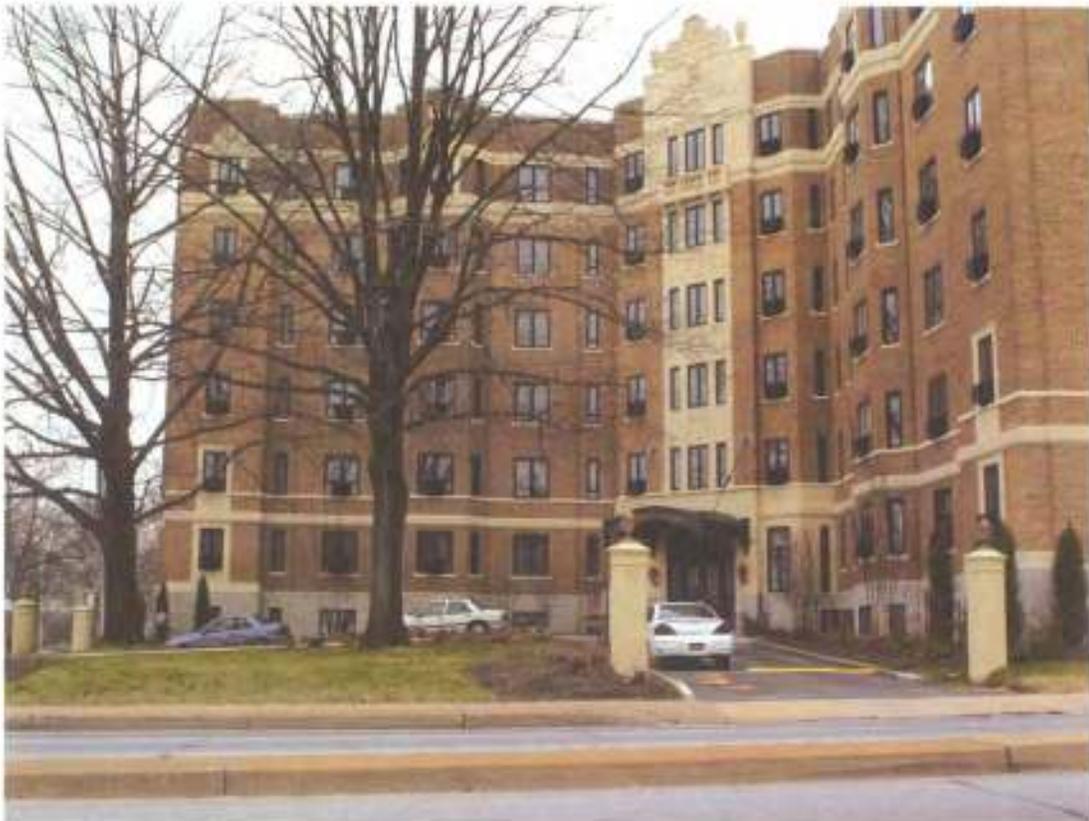
Plate 020 Rodney Court Apartments

The Rodney Court Apartment design with its circular drive allows room for plantings off the immediate streetscape (Plate 020).

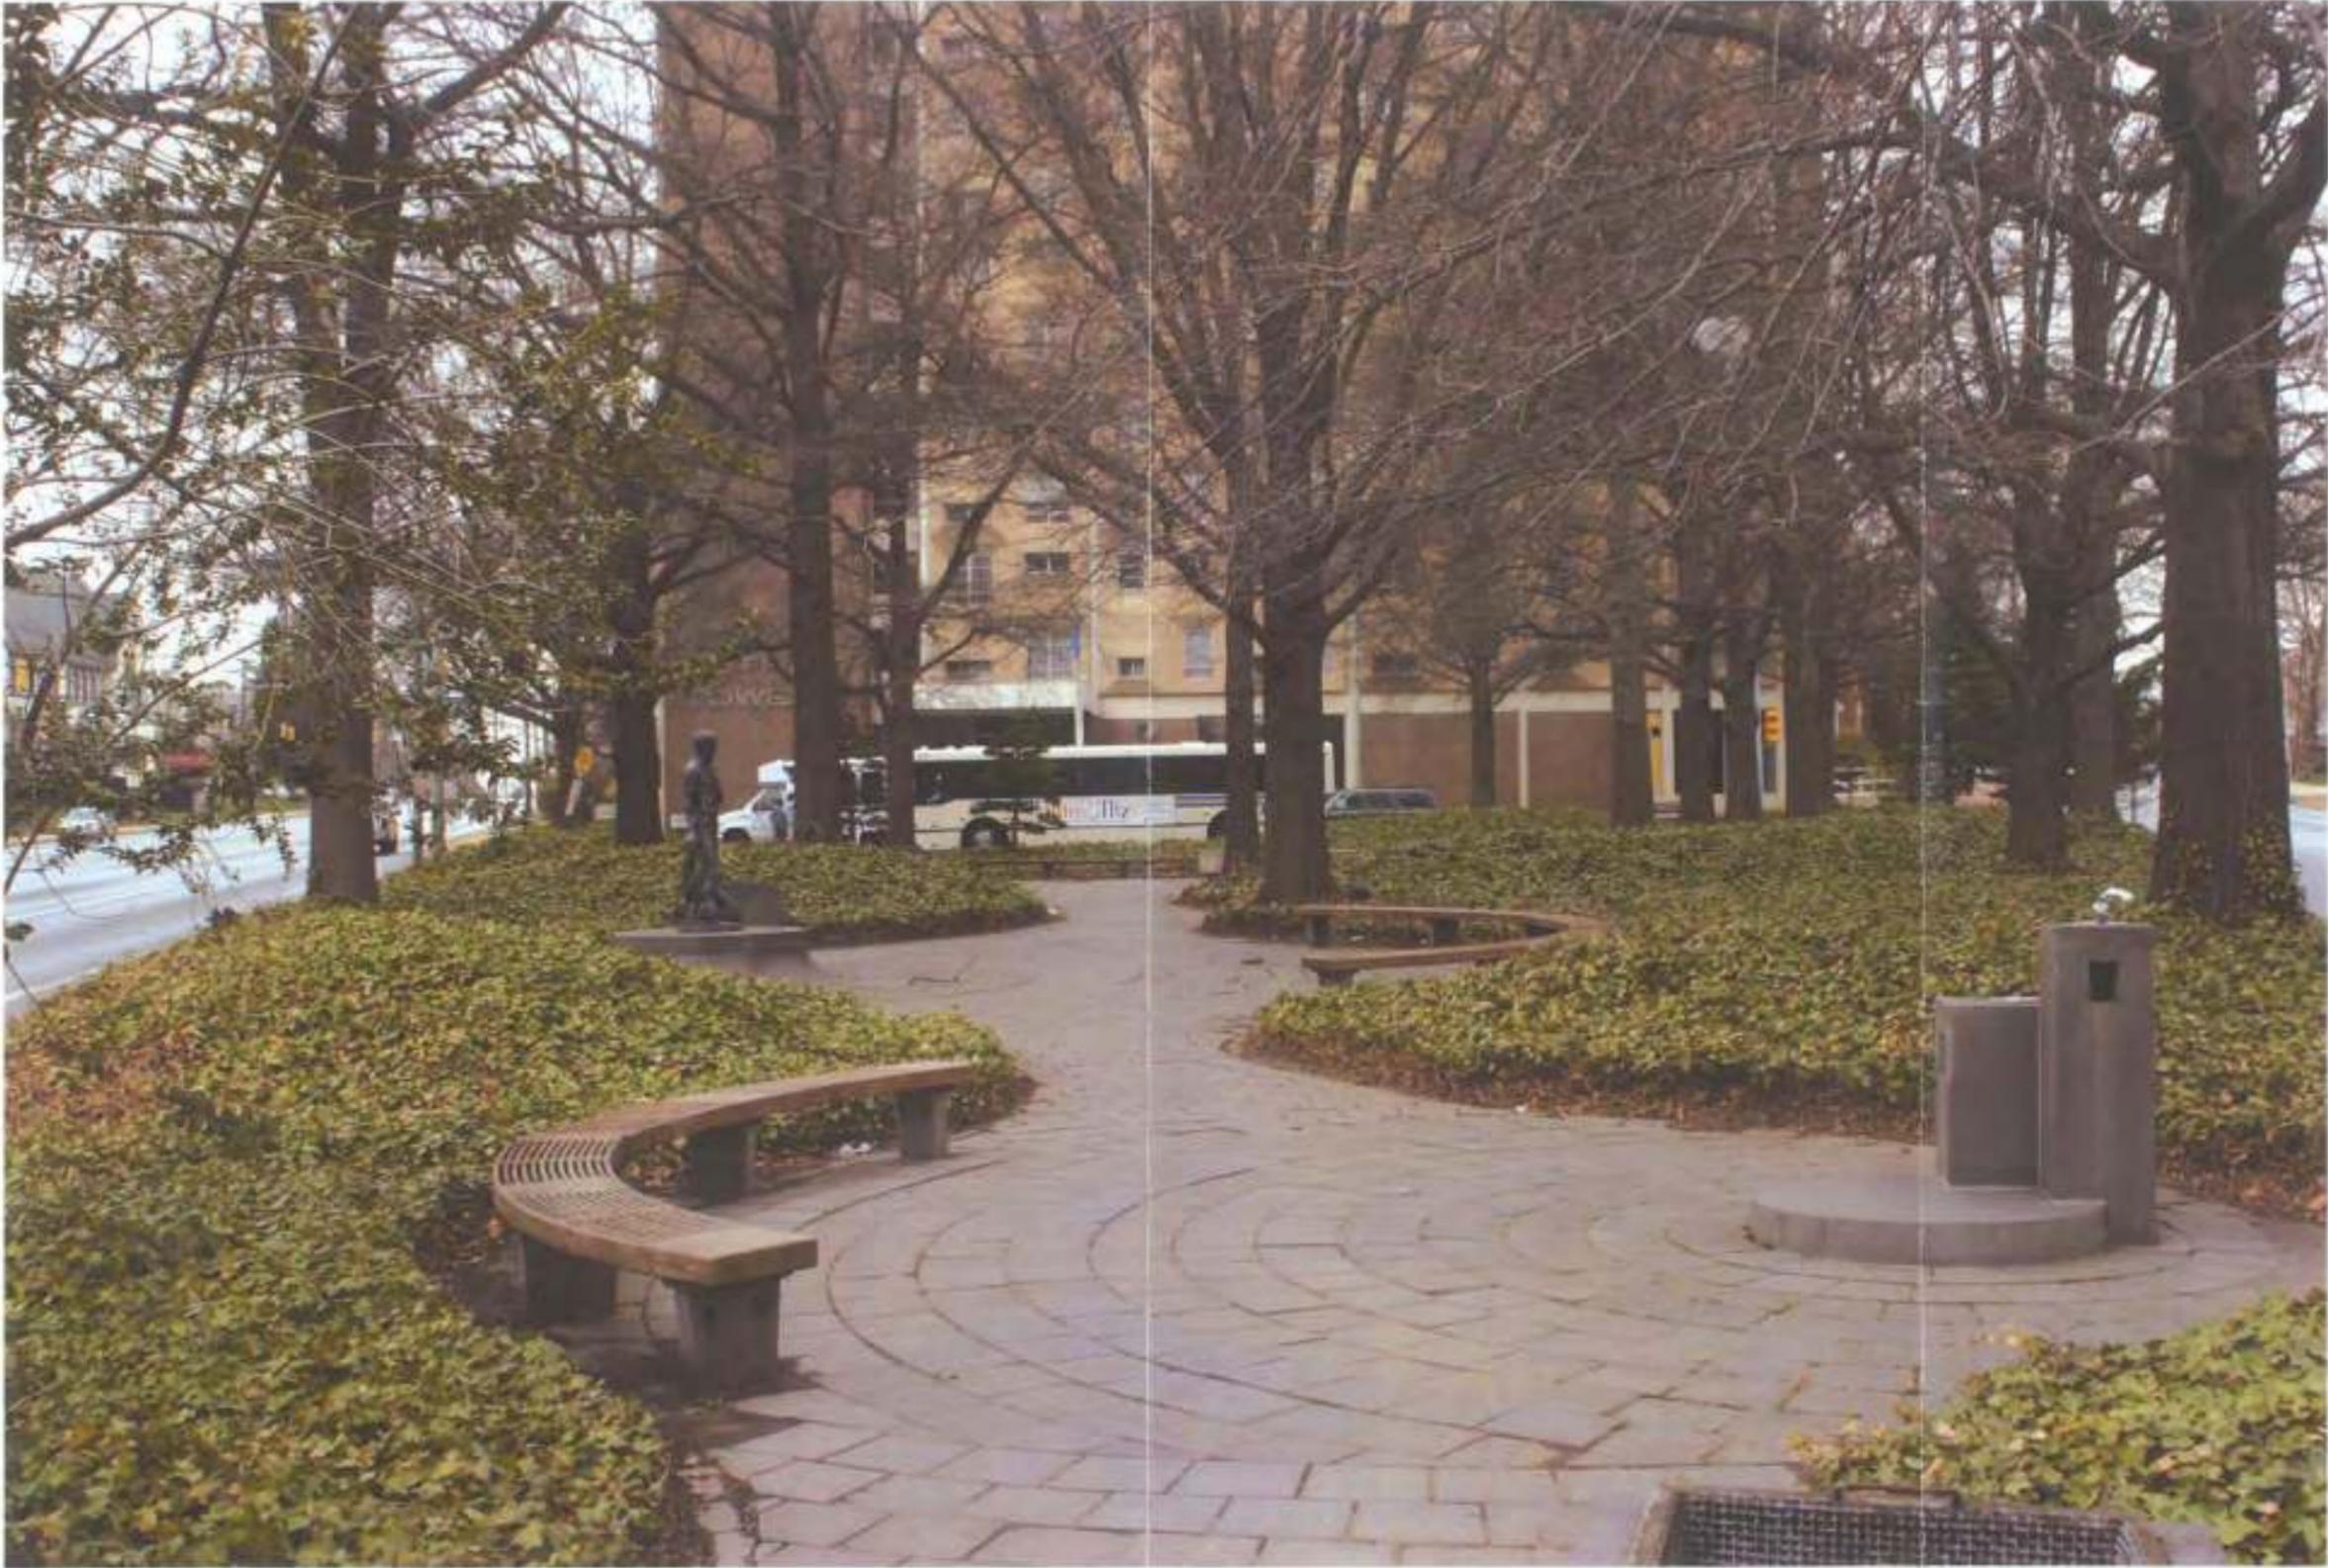
Plate 021. Fountain Plaza

Fountain Plaza, while having a pleasingly strong design with its evergreen forms, sculptural simplicity supplemented by the Charles Park Statue, and sense of enclosure, suffers from a dramatic lack of use. The poor pedestrian access and a slightly claustrophobic sense induced by the continuous ivy-covered berms add to the unwelcoming feel of this space (Plate 021, page 29).

- Provide greater pedestrian access and incentive for community use of Fountain Plaza. Consider berm reduction in selected areas avoiding damage to existing tree roots. Strategically remove ivy to provide a more inviting frontage at pedestrian access points and greater perceived security and pleasure for sitting areas. Provide topographic relief and maintain perceived enclosure by planting flowering shrubs (such as *Kerria japonica*, *Duetzia gracilis* 'Nikko' or *Spiraea* sp.) and perennials such as (*Geranium* 'Biokovo' and 'Biokovo Karmina' in semicircular sweeps that expand on the sculptural simplicity of the existing serpentine pattern as shown in Figures 8 and 9.

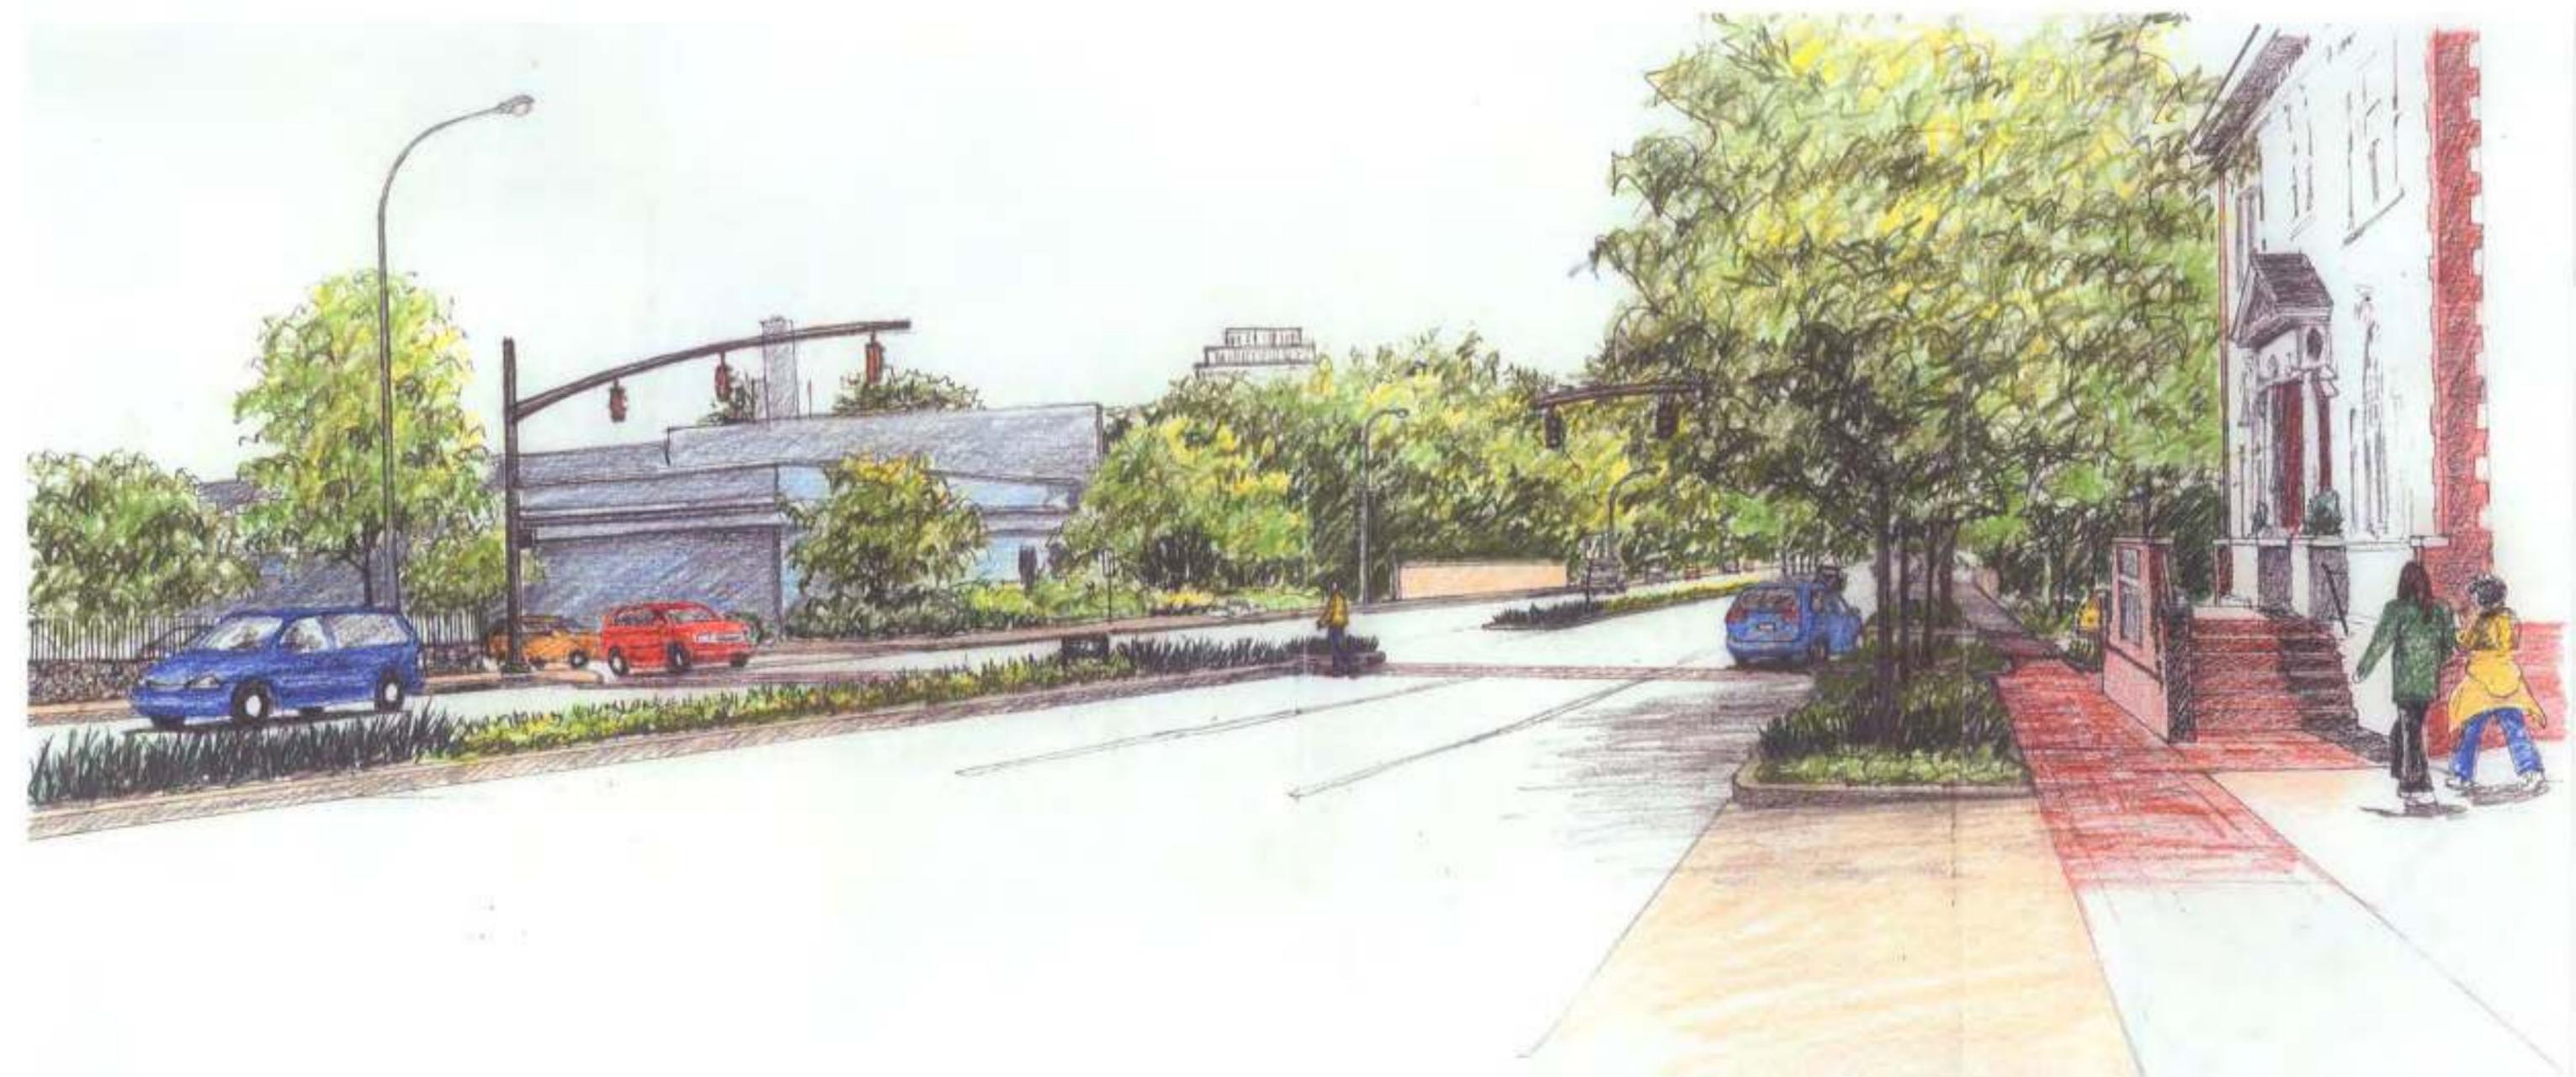
Figure 7. Children's Theatre Perspective

Sketch looking south

Illustrative plan

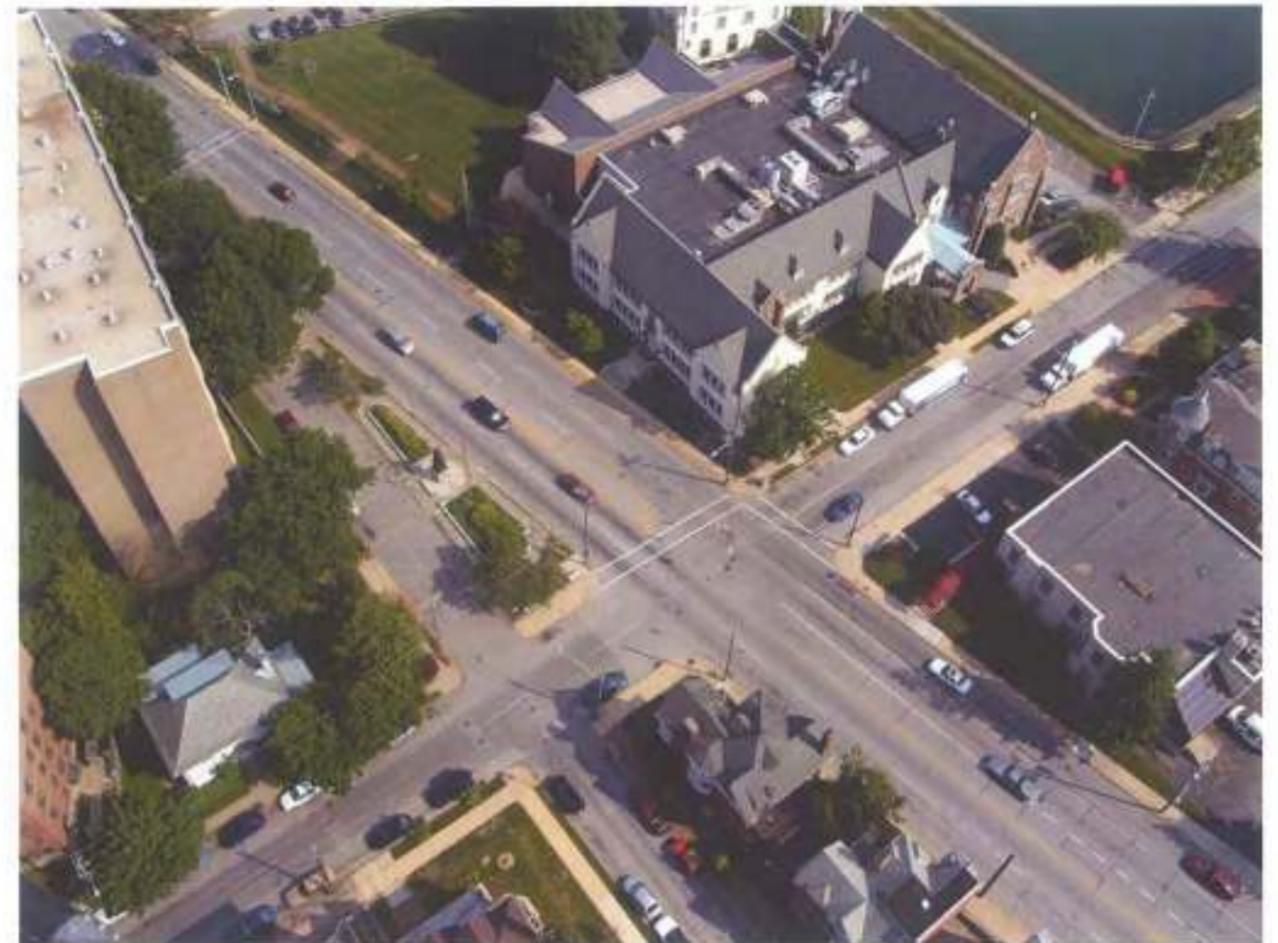
Plate D22 Pennsylvania Avenue and Broom Street, Columbus Park Plaza

The Columbus Park Plaza is a narrow strip of land situated between Pennsylvania Avenue and an extension of 13th Street (Plate 022). This section of street was deeded over to Luther Towers, the adjacent property owner, who was in the process of constructing a new driveway at press time. The appeal and usefulness of this plaza would be greatly enhanced if the new driveway were incorporated into a holistic renovation of the space with emphasis on the green elements. The existing park space is planted with inappropriate species pruned into unattractive shapes. The sidewalk is discontinuous and pedestrian traffic has worn a path in the turf (Plate 023). Renovating the park space would provide great opportunity to rectify this situation.

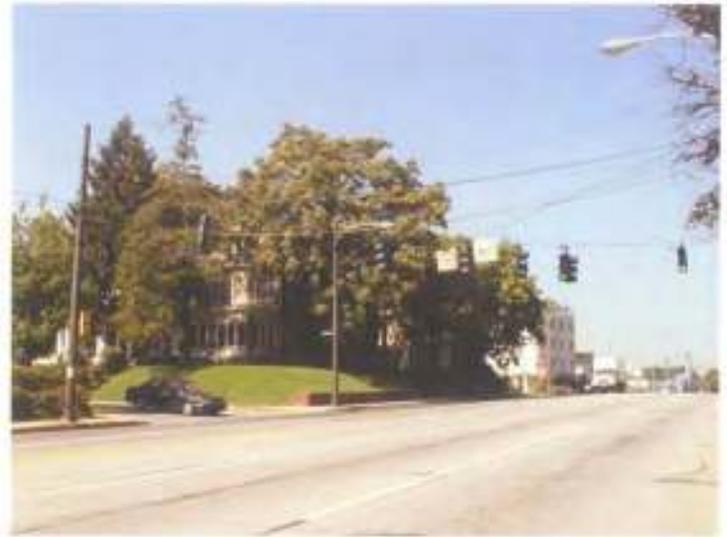
Plate 024
Ailanthus at Rodney Street and Pennsylvania Avenue

- Recommend removal and replacement of invasive species on private property such as this large tree-of-heaven (*Ailanthus altissima*) on the southwest corner of Rodney Street and Route 52 (Plate 024). An invasive plant can be defined as one that quickly overwhelms and displaces existing native plants by reducing the availability of light, water, nutrients and space. They have few, if any, natural controls to keep them in check. Trees like this tree-of-heaven represent a huge repository of seed that has the potential to invade unmaintained open spaces in the city.
- Renovate landscape planting at Columbus Plaza. Redesign paving to address pedestrian traffic and integrate ongoing surface renovations adjacent to Luther Towers into plaza space improvements (Figure 10).

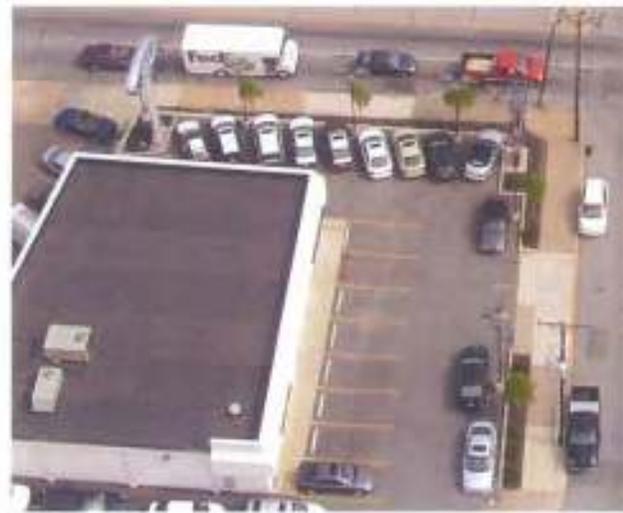
Plate 027
Typical new car lot on Pennsylvania Avenue

Due to the positions of overhead wires and new car displays close to the sidewalk there are few opportunities to plant tall-growing shade trees in this segment. Small flowering trees offer the best opportunity to soften this landscape and add seasonal interest (Plate 027). Sturdy trees, such as Donald Wyman crabapples are preferable to Callery pears, which are predisposed to weak limbs and breakage.

- Encourage the planting of small flowering trees and replace undesirable species (such as Callery pear) with appropriate street trees (City of Wilmington Recommended Street Tree List, Appendix B).

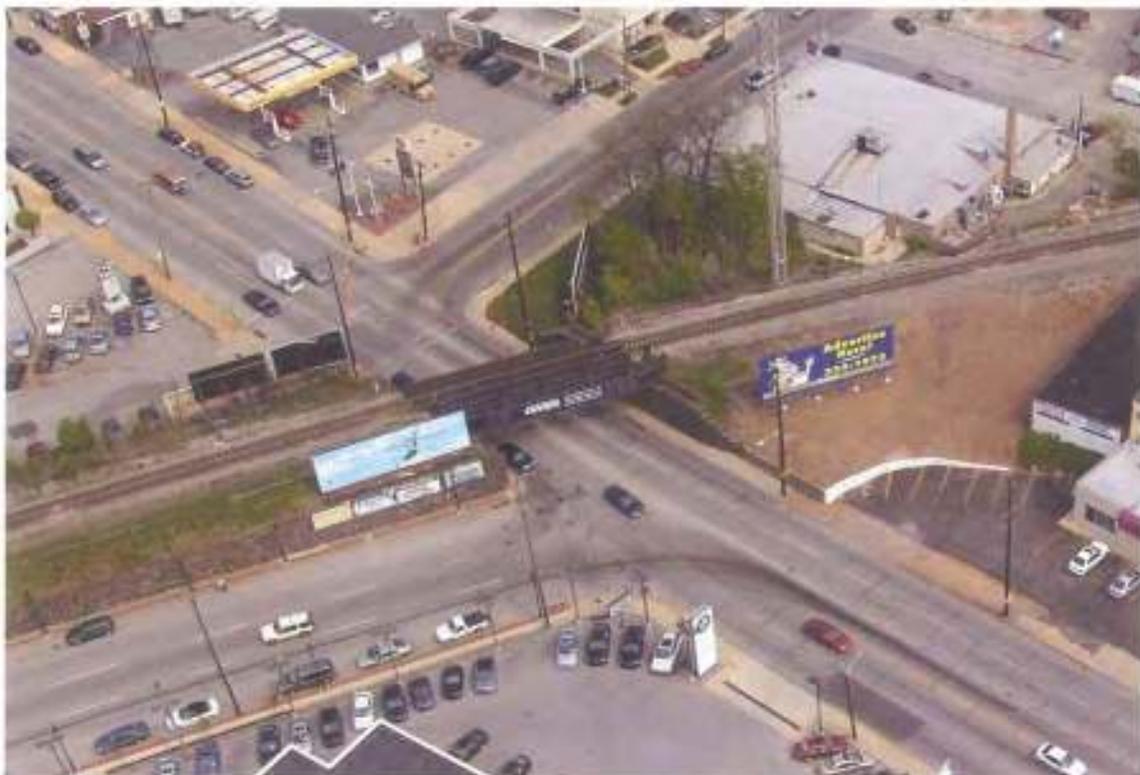
Plate 028 CSX railroad overpass at Pennsylvania Avenue

The Union Street intersection is currently unsafe for pedestrian traffic. The south-facing slope along Pennsylvania Avenue immediately to the east of the CSX overpass is barren and presents a great opportunity for attractive vegetation. This is one of the few places in the segment that would accommodate tall-growing shade trees (Plate 028).

- Develop a planting plan for the south-facing slope along Pennsylvania Avenue immediately to the east of the CSX overpass that includes ground cover plantings and tall-growing shade trees where appropriate (Figure 11, page 43).

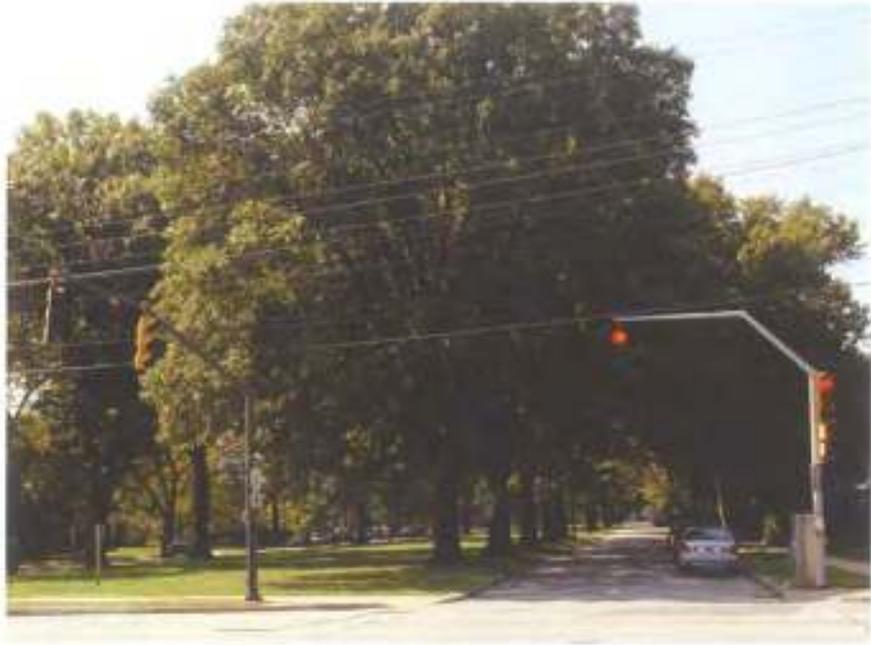
Plate 029 Bancroft Parkway at Pennsylvania Avenue

The majestic character of large canopy oaks defines Bancroft Parkway (Plate 029). This parkway invites tangents from travel along Route 52. It encourages the traveler to explore more of Wilmington. Bancroft Parkway should be protected and preserved. The trees in this parkway are a fragile biological resource. Any type of disturbance or construction activity, such as utility trenching could have disastrous results on tree survival (Plate 030).

- Develop a maintenance policy for Bancroft Parkway that includes maintenance and protection of existing oaks and replanting of oaks as needed (Figures 12a and 12b, pages 44 and 45).

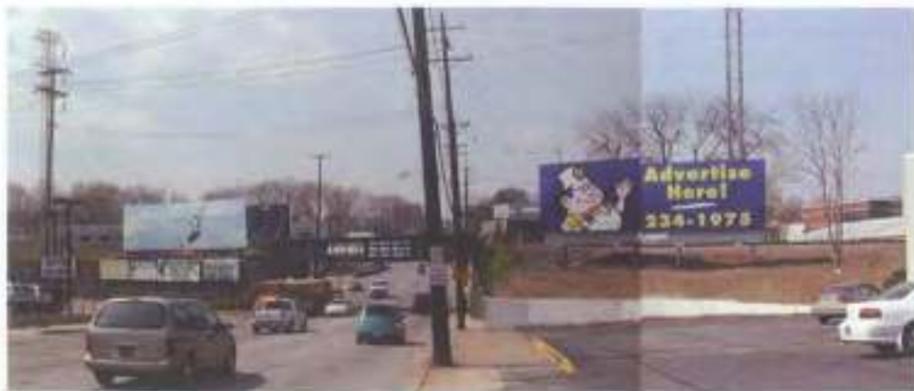
Figure 11. B&O Crossing

Above: View of crossing with proposed plantings
At left: Existing view of crossing
