Scenic Stewardship:

A Plan to Preserve and Enhance the Landscape
of the Brandywine Valley Scenic Byway

Regional Landscape Enhancement
Susan Barton
Rick Darke
Gary Schwetz
For Delaware Greenways

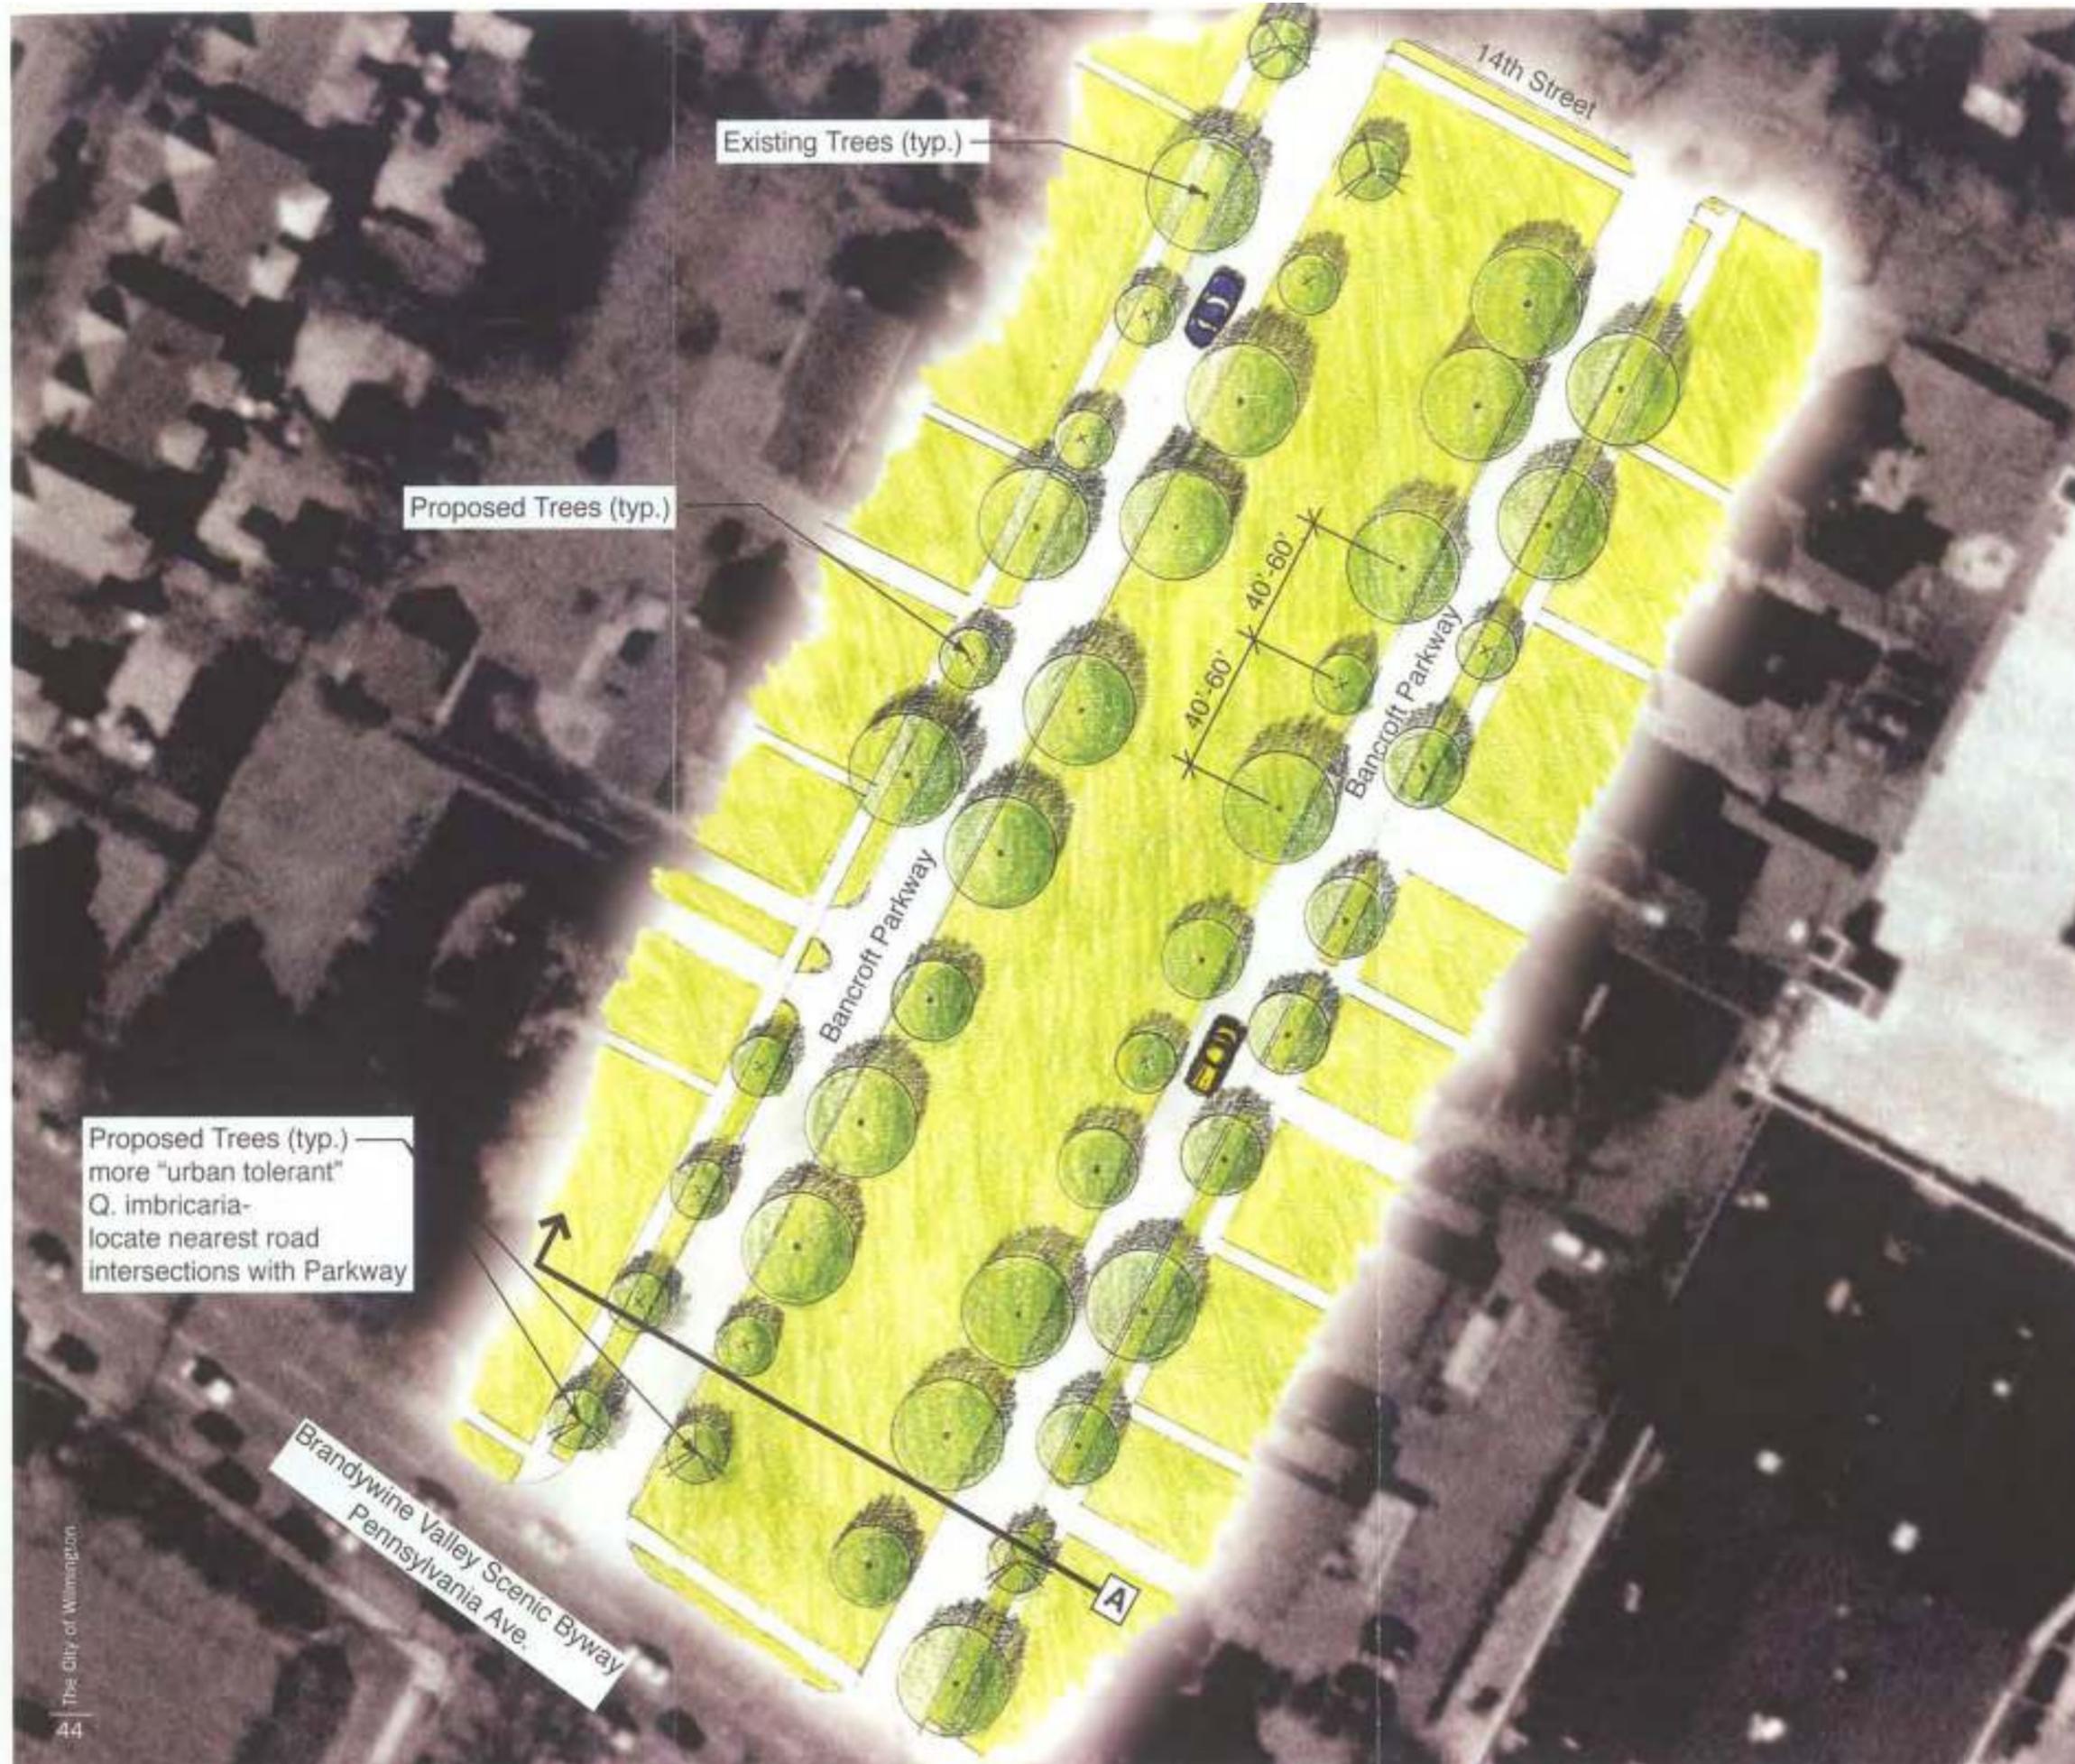
Figure 12b. Bancroft Parkway Tree Allee
 Infill Replacement Tree Recommendations
 Example Block: Pennsylvania Ave. to 14th St.

Apply location and tree species recommendations below to infill tree plantings and future replacement tree plantings.

Red oak species mix should include *Q. rubra*, *Q. phellos*, and *Q. palustris*.

Proposed Trees (typ.)
 more "urban tolerant"
Q. imbricaria-
 locate nearest road
 intersections with Parkway

- Develop a maintenance policy for Bancroft Parkway that includes maintenance and protection of existing oaks and replanting of oaks as needed (Figures 12a and 12b, pages 44 and 45).

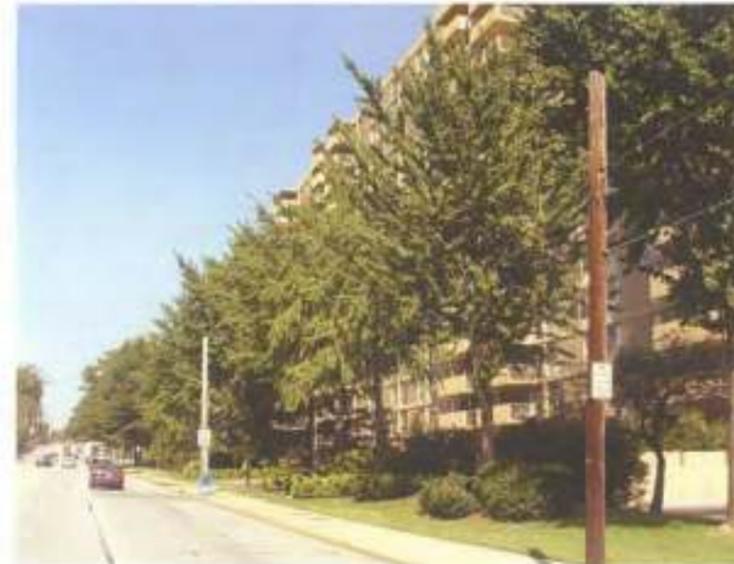
Plate 031
Gingko street trees on Pennsylvania Avenue

Gingkos planted in front of the Devon contribute to the appearance of a continuous woodland corridor (Plate 031).

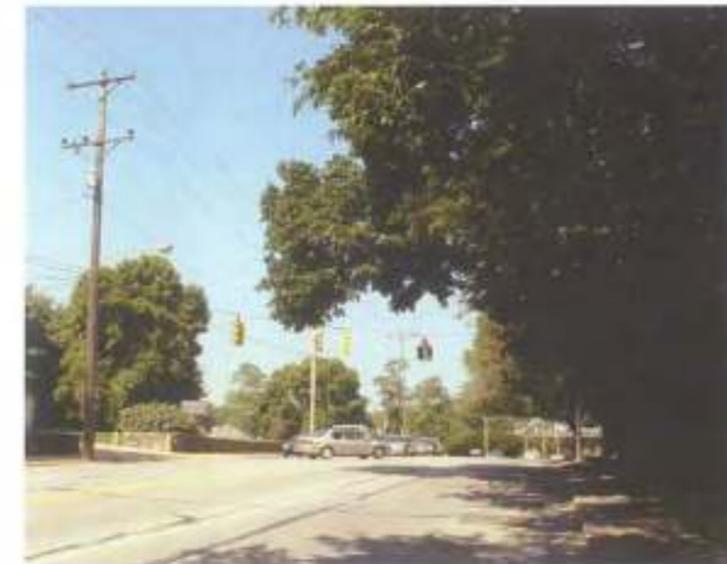
Plate 032
Trees over Pennsylvania Avenue

Trees at Gibraltar, although planted 30-40 feet away from the road, add to motorists' sense of an urban canopy. However, management plans should be in place to ensure that such trees do not develop low limbs hanging over the road in the direct path of passing trucks and other tall vehicles (Plate 032).

- Maintain and manage tree canopy at Gibraltar to be compatible with corridor traffic. Remove low limbs extending out over the travel lanes.
- Install traffic islands to reduce the perceived road width and calm traffic. Use vegetation when islands are large enough to accommodate plantings (at least 3 feet or wider).

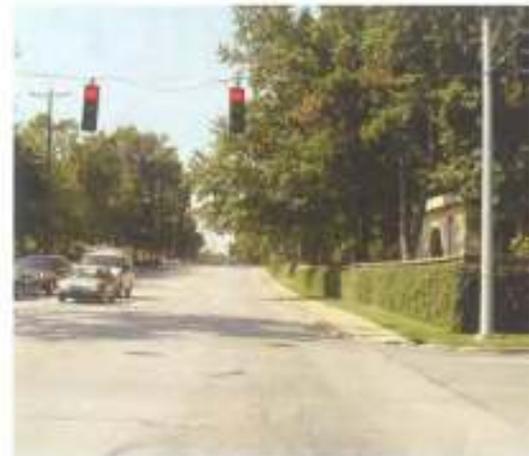
Plate 033 Stone wall at Gibraltar

Gibraltar contains a unique collection of mature horticultural specimens. This original Marian Coffin landscape design, with some renovation through the years, has a significant impact on the aesthetics of the 52 Scenic Byway. The six-foot-high wall allows motorists a glimpse of horticultural richness lying within (Plate 033).

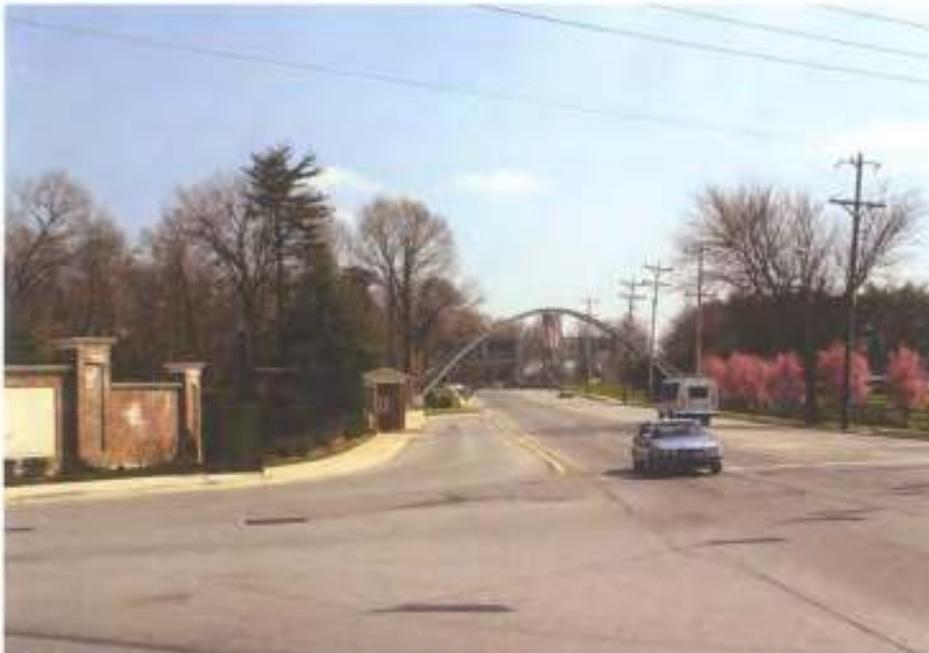
Plate 034 Tower Hill pedestrian overpass on Pennsylvania Avenue

Crossings at several schools in this segment are inadequate to meet pedestrian needs. The Tower Hill overpass meets some of the crossing demand for school events, but its location and elevated nature make it an inconvenient choice for pedestrians wishing to cross Pennsylvania Avenue at Rising Sun Lane (Plate 034). Significant improvements to this intersection have accommodated buses and their passengers. While the pedestrian volume indicates addition of crosswalks, the narrow width of the current road configuration prevents the use of traditional traffic calming and safety measures such as bump out or center median islands. The wider road surface at A.I. duPont Middle School, in segment 6, may be more conducive to standard traffic calming measures.

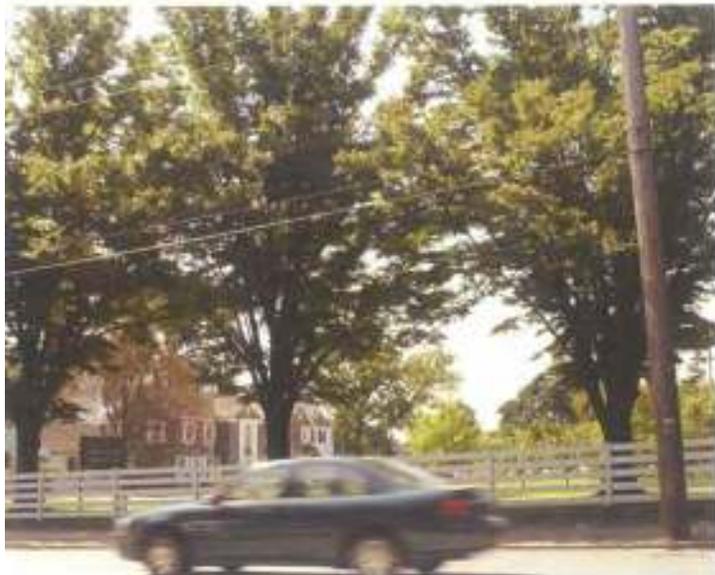
Plate 036
Zelkova trees at Goodstay Center

Mature plantings at Goodstay Center contribute significantly to the appearance of the byway. Some specimens are planted at great distance, but are visible to motorists. A row of trees (zelkova and other deciduous species) is set back just far enough from the roadway to avoid conflict with utility lines yet provides a pleasant green canopy that helps shade the sidewalk (Plate 036). In contrast, this tree planted directly under the utility lines (Plate 037) has required pruning resulting in an unattractive appearance.

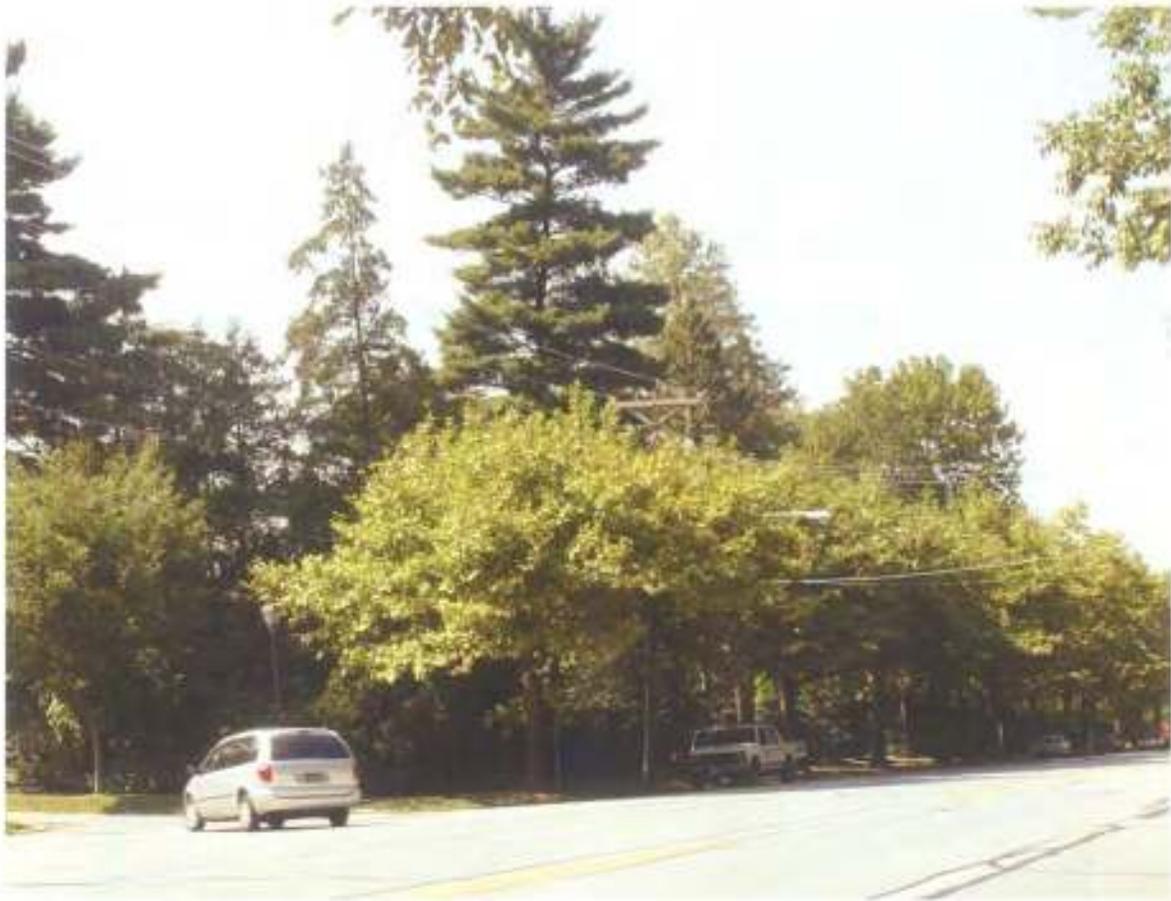
Plate 038: London Plane trees treated with growth retardant and pruned for utility line clearance.

At the corner of Westover Road and Route 52, London plane trees have been topped for decades to avoid conflict with utility lines. Though this practice is typically costly and detrimental to trees' long-term survival, recent developments in the use of growth hormones have reduced pruning maintenance while extending the trees' useful life (Plate 038).

- The service life of existing trees growing directly underneath electrical utility lines may be increased by a combination of pollarding and the use of chemical growth retardants (see Plate 038, page 52). This will necessarily compromise the tree's form.

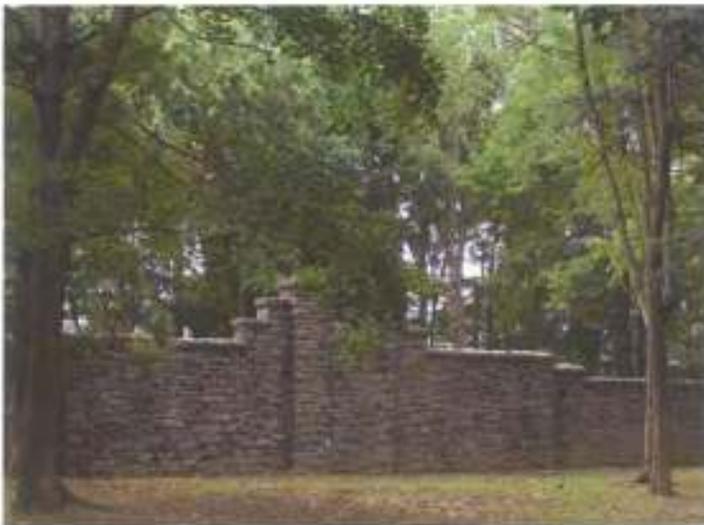
Plate 039
Stone wall by Marian Coffin on Tower Hill School property

Property adjacent to Tower Hill School includes a stone wall designed by renowned landscape architect, Marian Coffin, which is readily visible from the road. It is a valuable and attractive reminder of the duPont estate era (Plate 039).

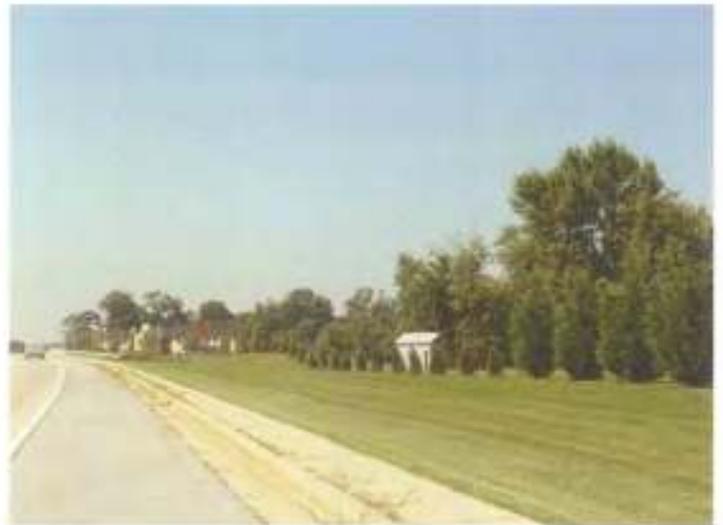
Plate 040
Leyland cypress hedge at St. Joseph's Church

The continuous row of Leyland cypress planted to screen St. Joseph's church property and cemetery from Route 52 will eventually result in an oppressive wall that diminishes the experience of the byway. The church and the byway would be better served by intermittent plantings of deciduous flowering and tall-growing shade trees and better-adapted evergreen trees that would create a psychological screen without completely separating the two landscapes (Plate 040). Leyland cypress is a poor choice for screening in this area. These short-lived trees frequently suffer from winter desiccation, are prone to insect and disease damage, and develop inadequate root systems that often result in lodging or toppling (Plate 041).

- Replace leyland cypress hedge with mixed plantings of deciduous and better-adapted evergreen trees that will create a psychological screen without completely separating the two landscapes (Figures 16 and 17, pages 60 and 61).

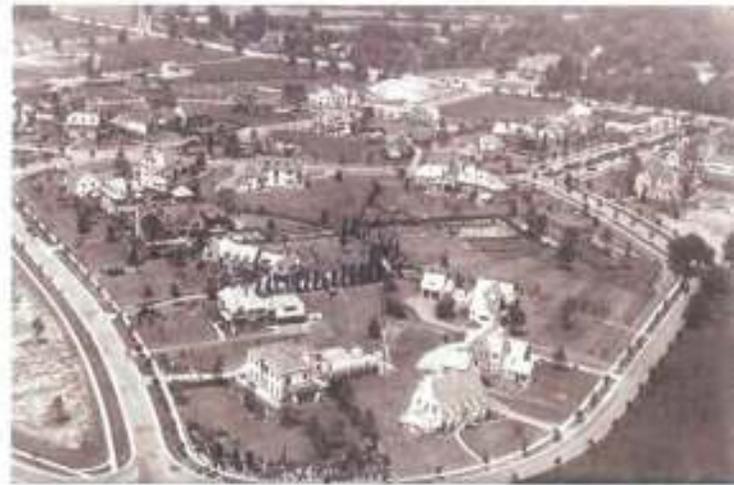
Plate 043
Aerial photos of Westover Hills taken 75 years apart depicting dramatic tree canopy growth. Note Dupont Road on lower left.

The open, rural appearance of the landscape as shown in historic photos from the early 1900s (Plate 042) is the result of 150 years of agriculture that removed deciduous woodlands, once the dominant vegetation of the region. Built on former farmland shown at top left, Westover Hills was originally treeless. Landowners planted large-growing trees, already in evidence in this 1930 photo (Plate 043). Seventy-five years later, the elegant, tree-lined streets have become essential to the character of this neighborhood (Plate 044, Plate 045).

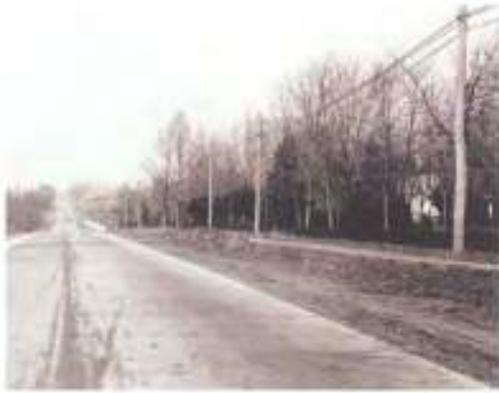
Plate 046
Traditional roadside hedge on Kennett
Pike, ca. 1919

In the estate era of the early 1900s, hedges were used to define property lines. Seen in both historic and current images (Plate 046, Plate 047) this hedge of common privet, *Ligustrum vulgare*, is an example. Such hedges along Route 52 are an important historic aesthetic element to maintain. The traditional species used for these hedges, the common privet, is increasingly recognized for its potential to invade and disrupt the ecological balance of natural areas in northern Delaware. Privet should be replaced whenever possible with a non-invasive hedge species. Reducing the seed source will help protect local habitats adjacent to the byway.

- Encourage the use of noninvasive alternatives such as *Myrica pensylvanica*, *Aronia arbutifolia*, *Viburnum prunifolium*, *Forsythia x intermedia*, *Abelia grandiflora* and *Spiraea* spp. to privet whenever opportunities present themselves to replace existing hedges.

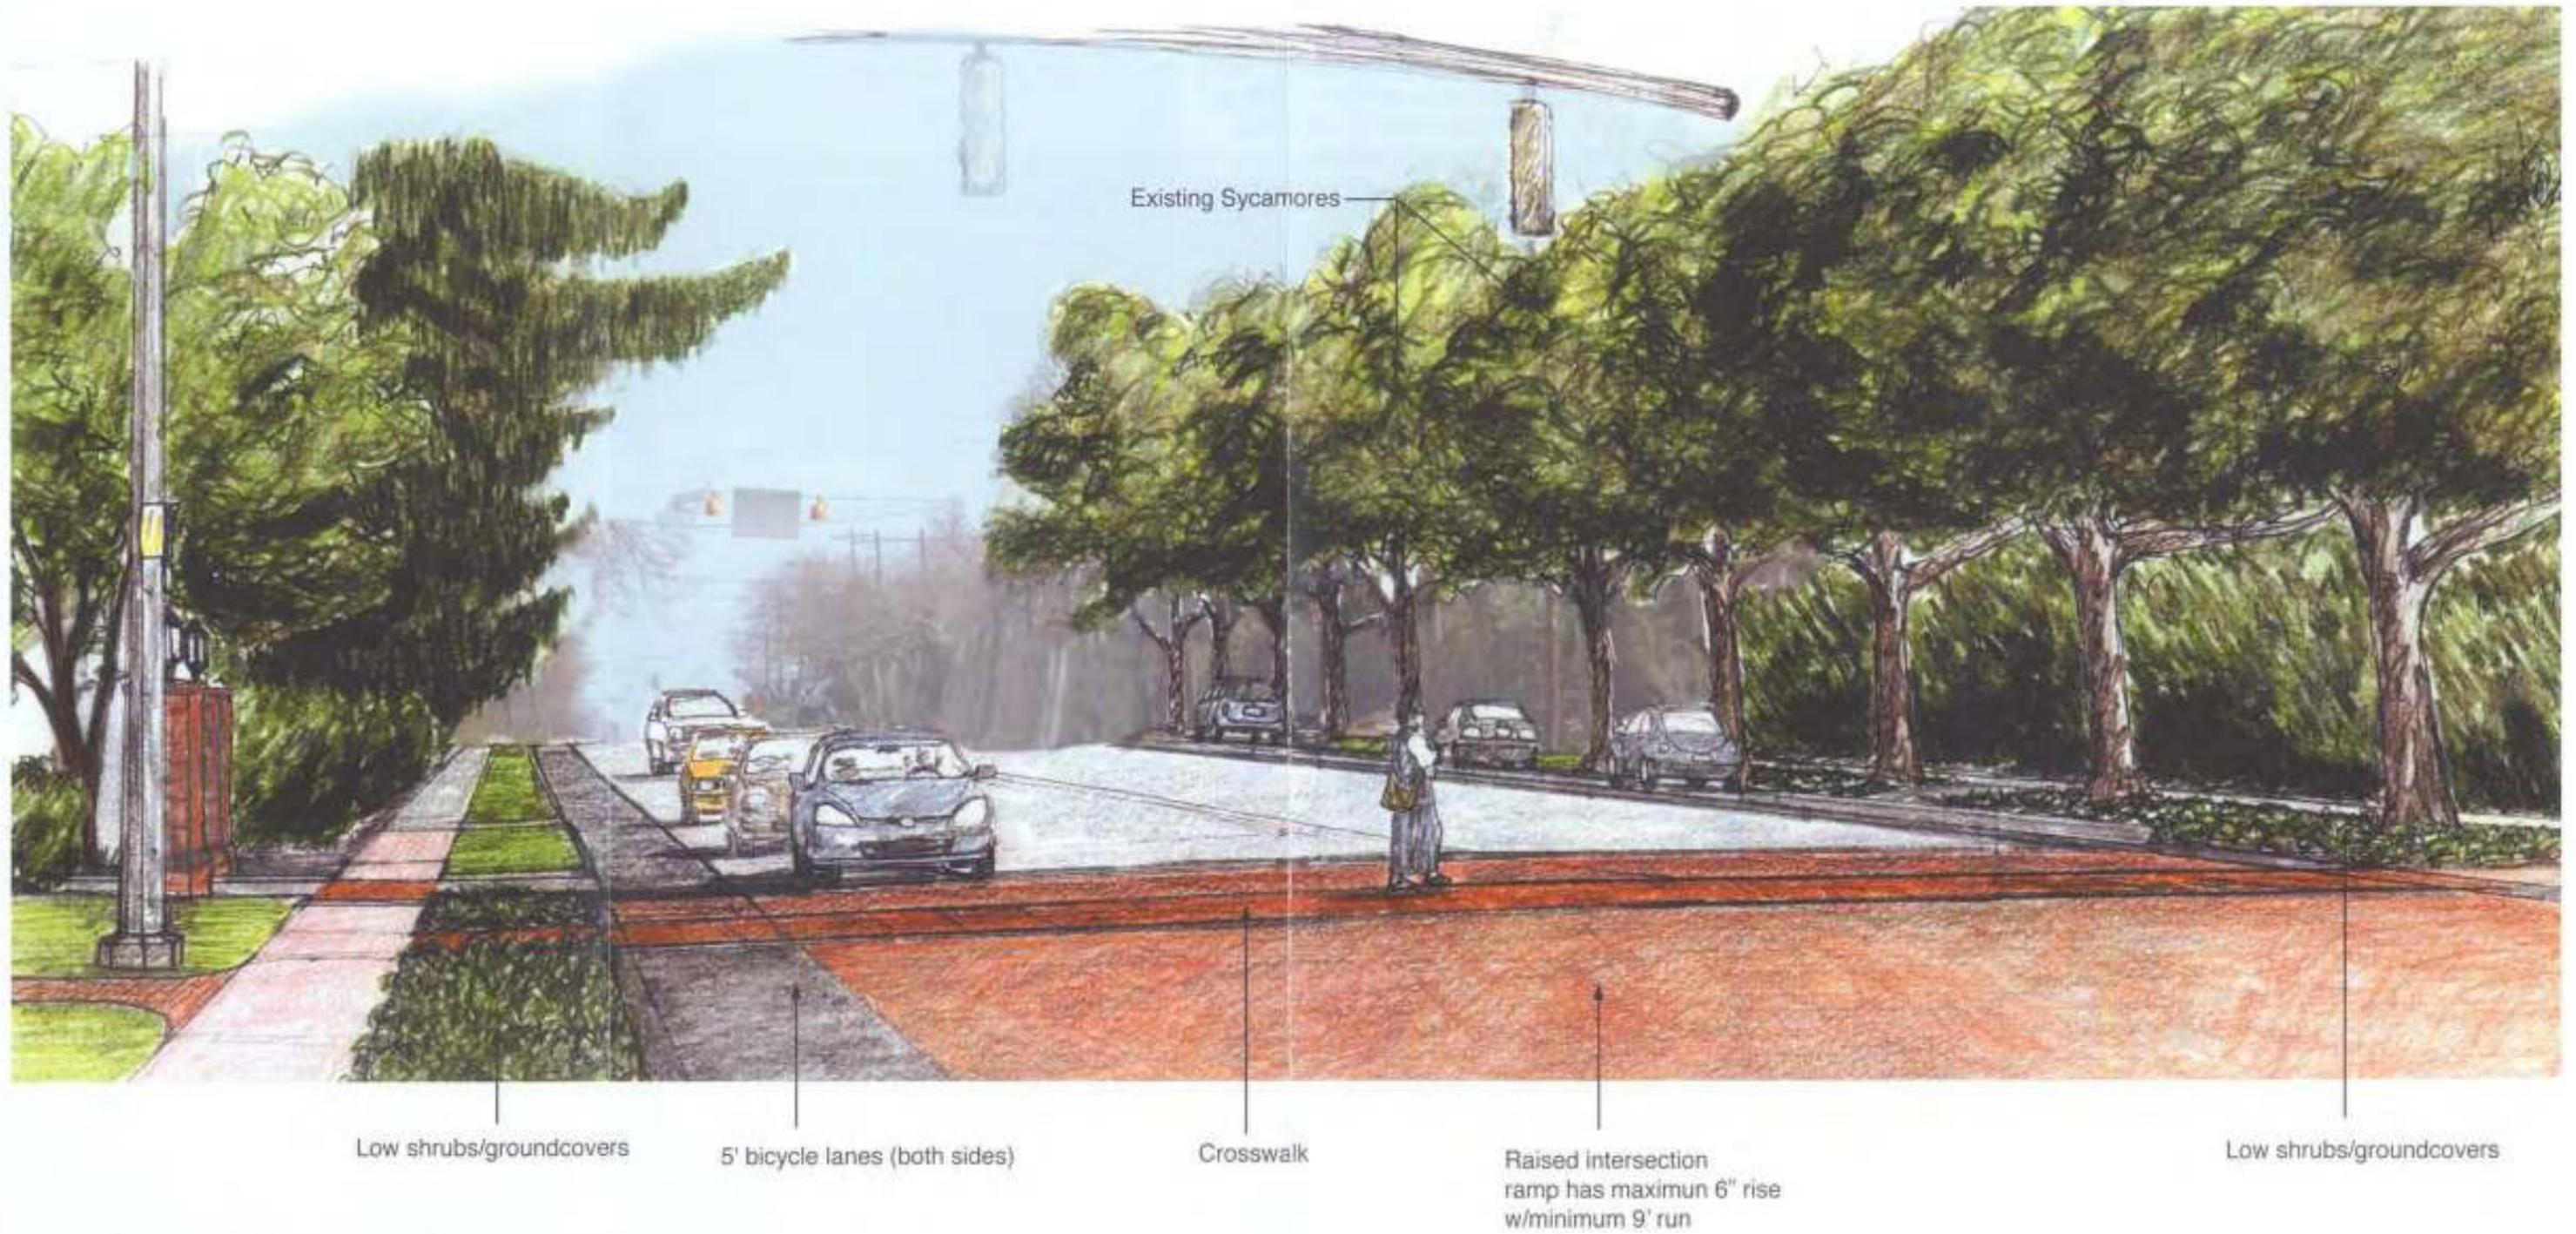
Figure 14. A.I. Dupont Middle School

Color and texture of bicycle lanes, raised intersection components, ramps and on-street parking to visually and audibly contrast with asphalt travel lanes.

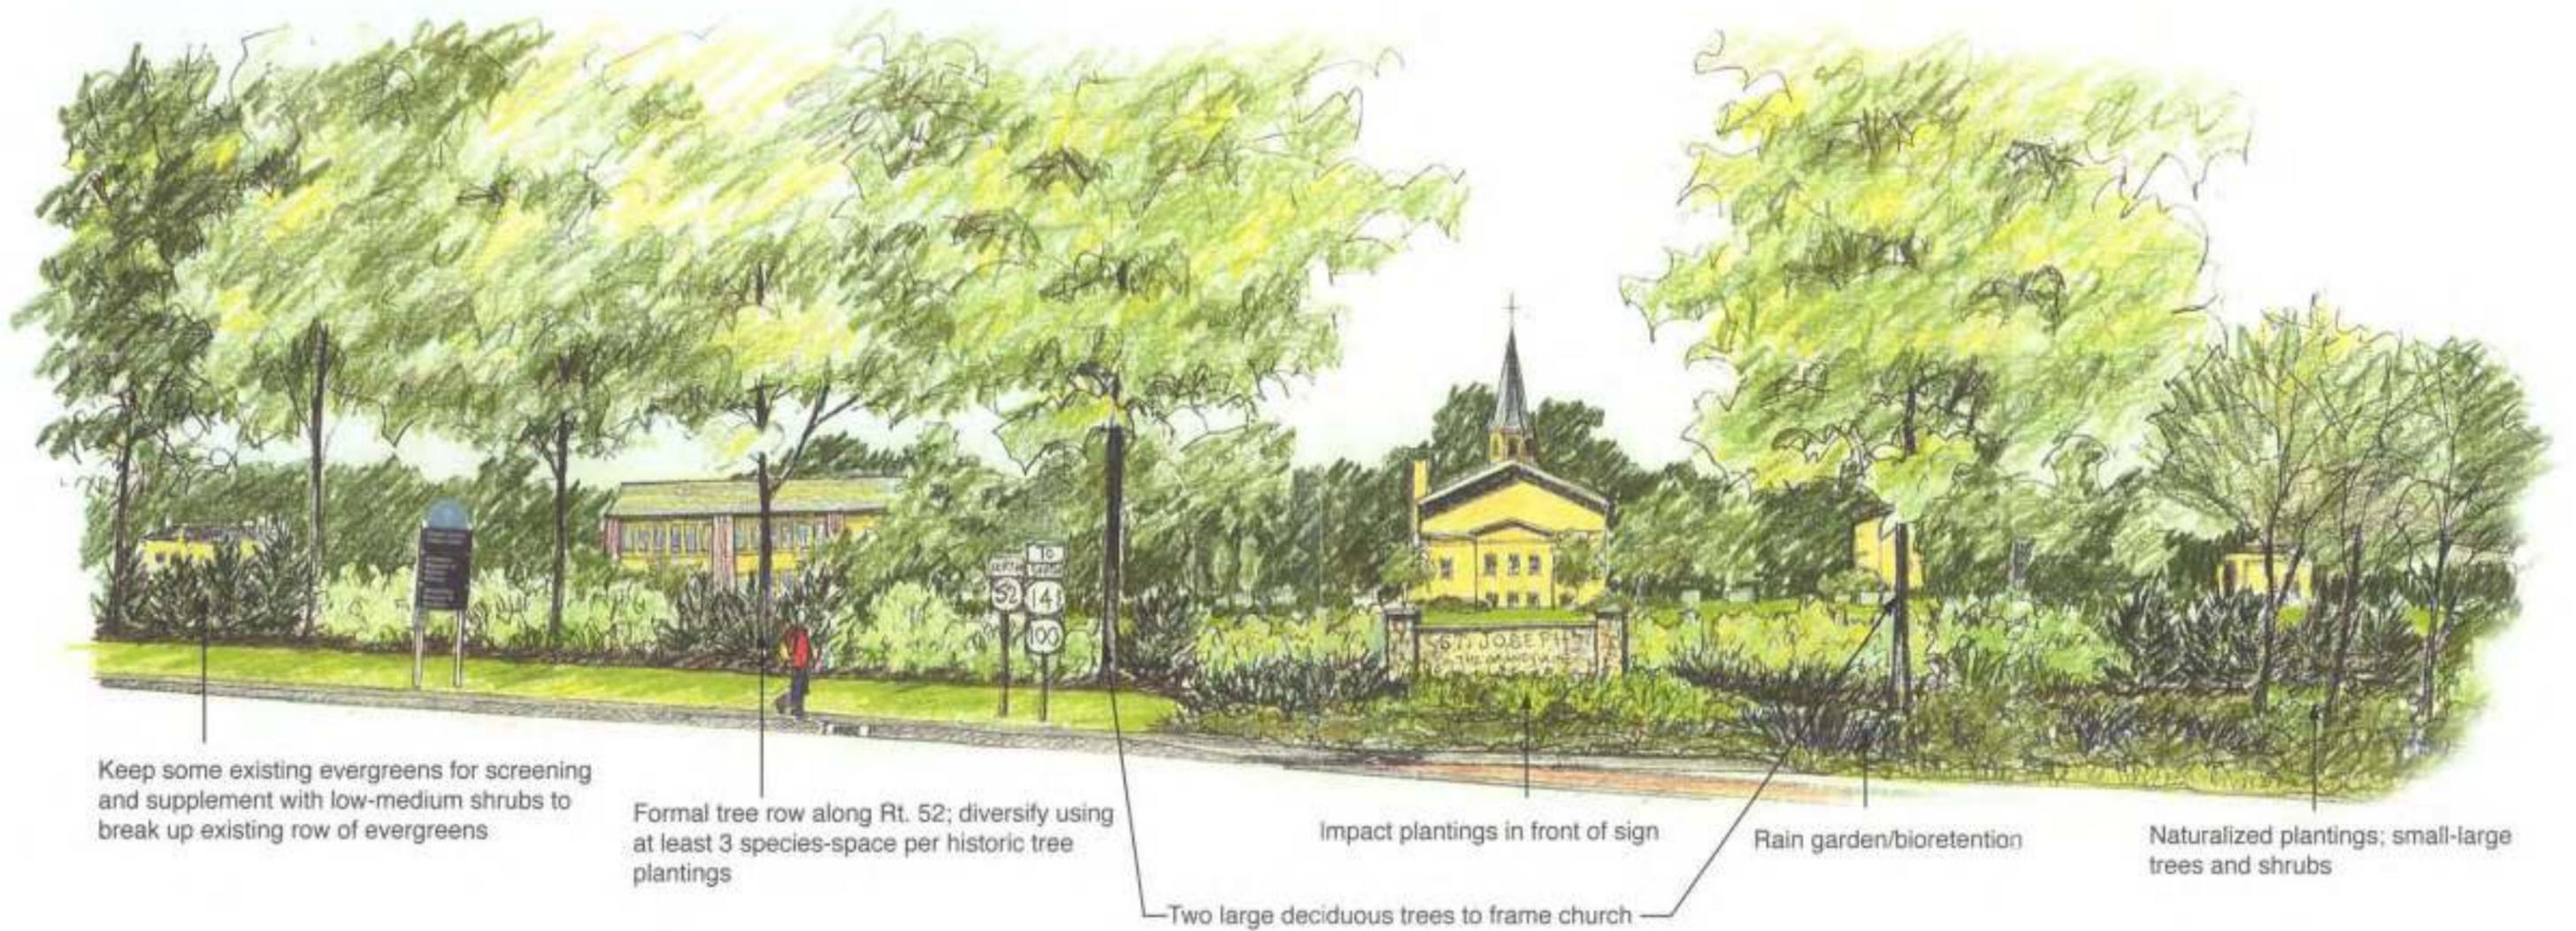
Figure 17. St. Joseph's on the Brandywine

Perspective looking north towards church from Byway

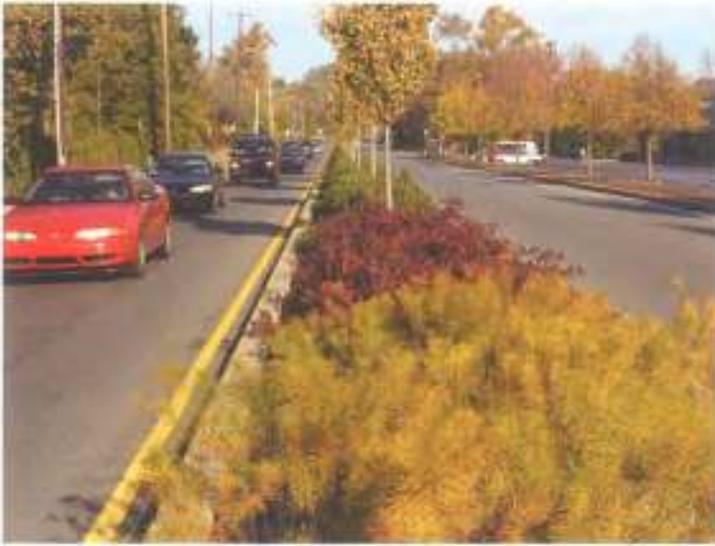
Plate 053

Planted medians (Plate 053), granite curbs and pavers (Plate 054), and patterned crosswalks (Plate 055) have provided effective traffic calming in Greenville. These enhancements create a sense of pedestrian scale and safety (Plate 056).

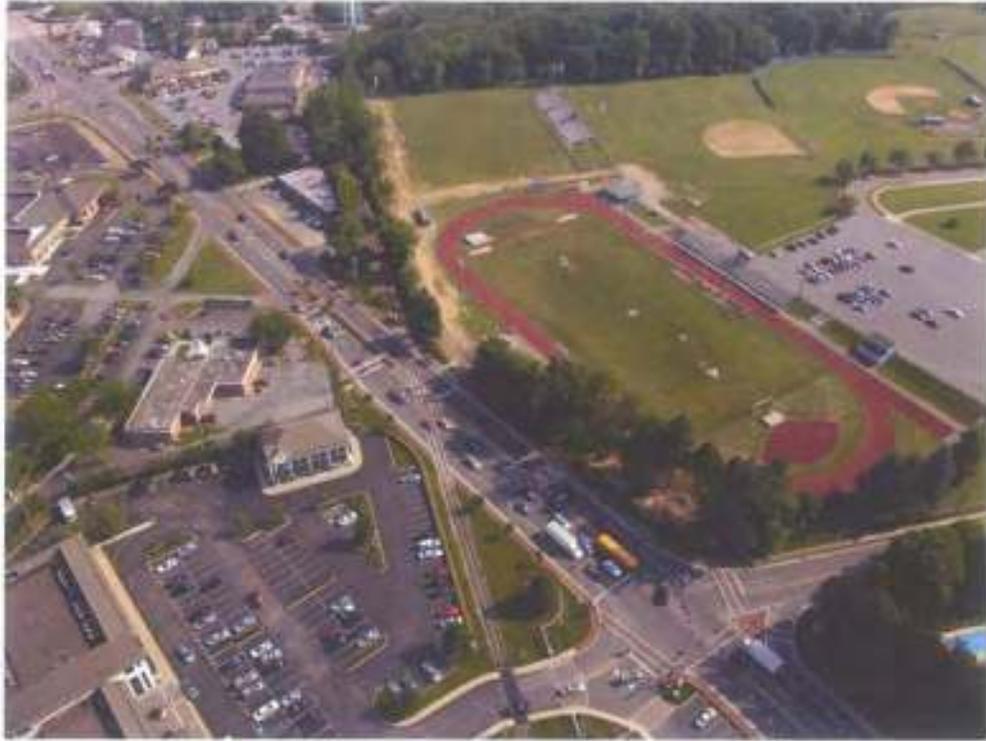
Plate 057: A. L. du Pont High School athletic fields

The evergreen screen around Al du Pont High School field is no longer functional. The planted zelkova won't perform the screening function. While the open space from athletic fields is a potentially desirable view, some sections of the existing chain link

fence are unattractive and obscure the view. During March 2004, most of the fence was replaced with a new chain link fence. An attractive black fence was placed at the corner of Route 52 and Hillside Road. The old chain link fence remains in a section directly behind the high school bleachers (Plate 057).

- Replace the remaining chain link fence with an attractive alternative behind the A.I. du Pont High School bleachers. Remove invasive species along the fence.
- Place utility lines in this segment underground (Figure 18).
- Plant tall-growing shade trees that can be limbed up for maximized commercial visibility and enhanced village character.
- When new building and renovations occur, take every opportunity to incorporate trees, shrubs and green spaces. To create a pleasant atmosphere for the shopping district plant tall-growing shade trees adjacent to the parking lot on the corner of Kennett Pike and Buck Road.
- Buffer parking lot with roadside plantings and/or structures to beautify and screen other properties and traveling motorists from headlights (see Figures 2-5, pages 20-23).

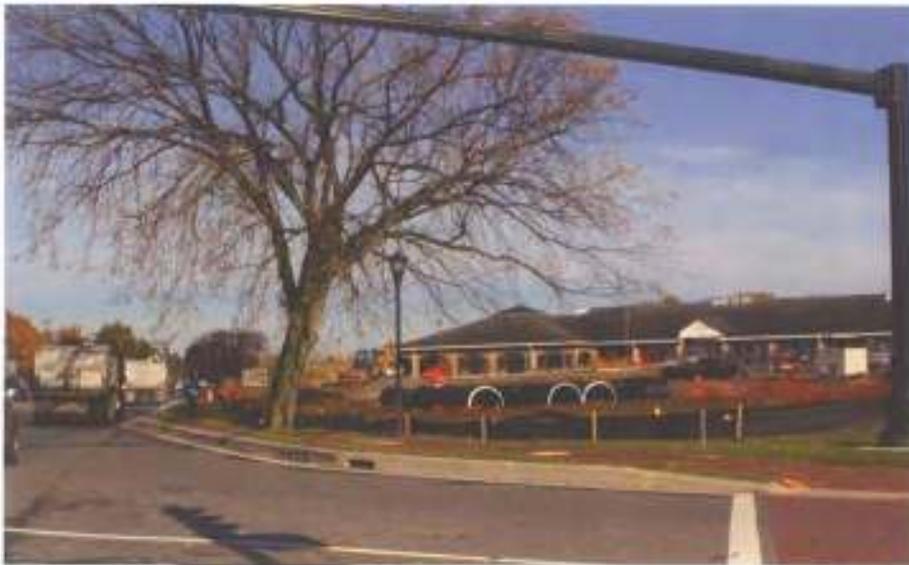
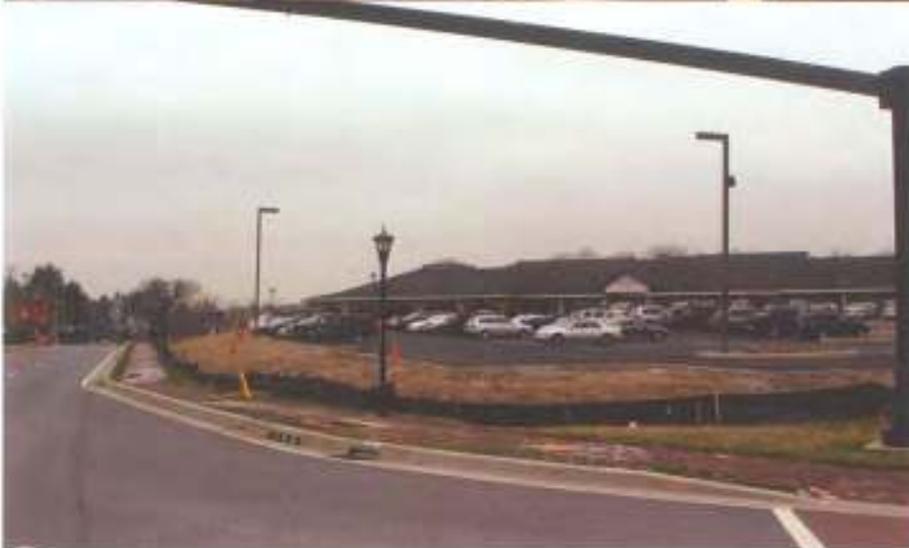
Plate 059 Lost mature elm at Buck Road and Kennett Pike

The loss of even a single mature tree can dramatically reduce the aesthetic quality of a section of roadway (Plate 059). Although this large elm was lost during the construction process, parking lot expansion at the corner of Kennett Pike and Buck Road resulted in new opportunities to plant tall-growing shade trees, screening and beautification plantings. Screening is designed to prevent headlight glare from impacting the surrounding residential and commercial environment.

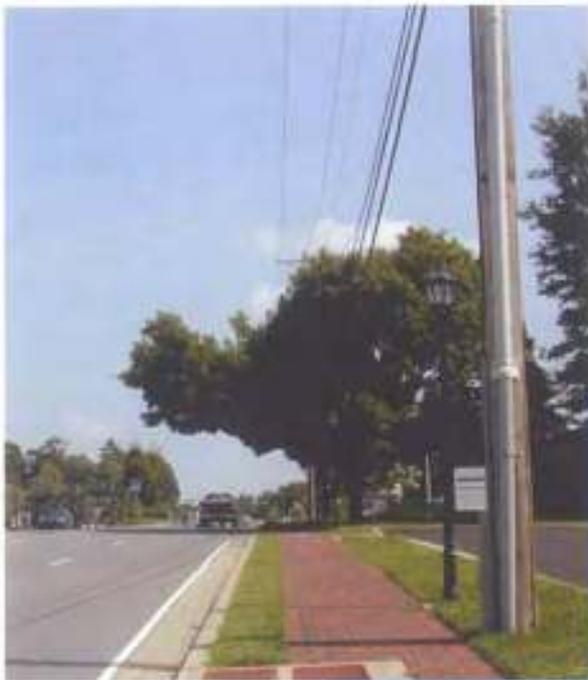
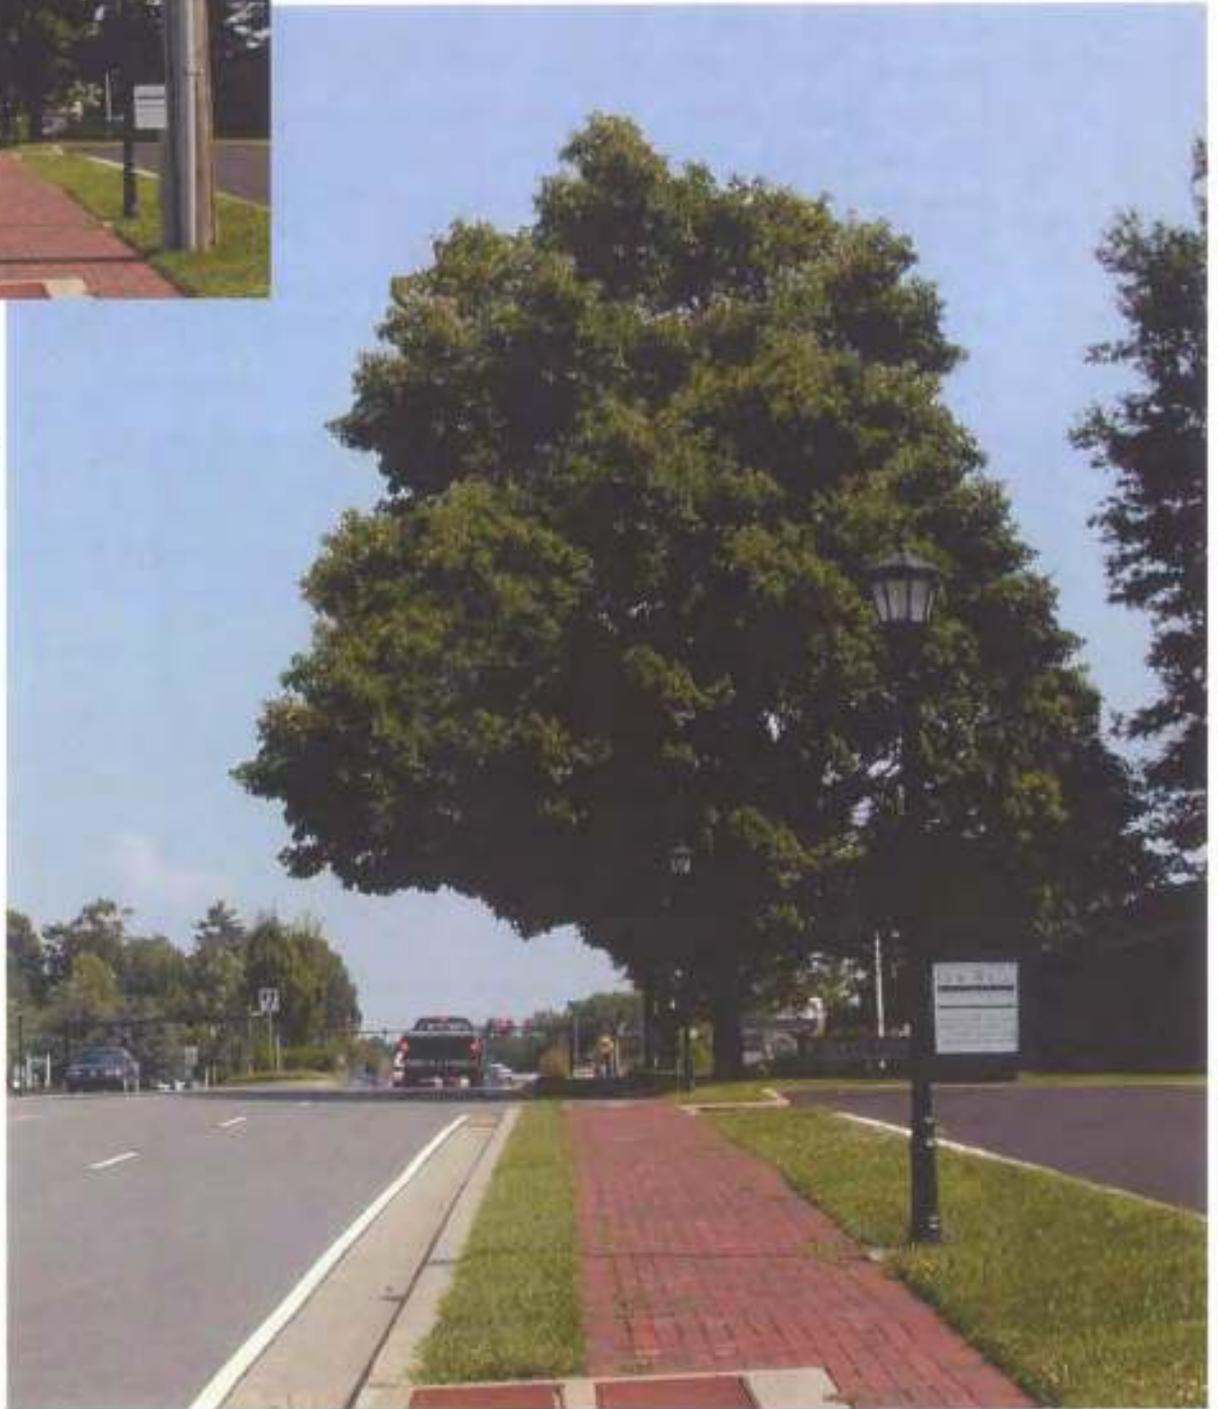
Figure 18. Village of Greenville

Above:
Existing view of
sugar maple with
above ground utilities.

Photo simulation of sugar maple growth after utilities are placed underground

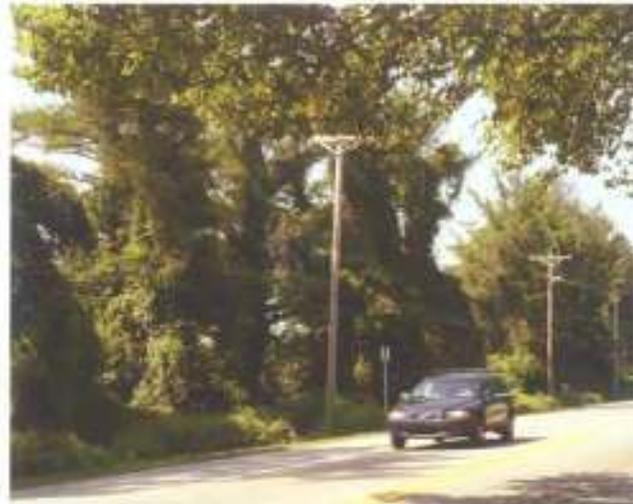
Plate 060 Vines blocking Twin Lakes view shed. 2004

Planted in the early 1900s by Eugene du Pont, European larches, *Larix decidua*, line the west side of the byway in the first portion of this segment. Climbing, choking vines have significantly diminished the trees' form and health (Plate 060). This is the result of inadequate ground layer maintenance. Planted at the rear edge of the right-of-way and pyramidal in nature, the larches could have (with proper maintenance) created a soft-textured screen compatible with utility lines. Since this photo, property owners are working diligently toward removing the curtain of vines, blocking what would be high quality views such as the twin lakes estates. Other significant sections of the byway (for example: directly across from Winterthur (Plate 061) and a section just north of the Delaware Museum of Natural History) are overgrown with invasive vines and shrubs.

- Reduce road width and/or design plantings to create environments that alert drivers to the need for caution upon approach to Greenville (Figures 19, and 20, pages 71 and 72).
- Remove larch trees choked with invasive vines from Brook Valley Road to Campbell Road (Route 82) and replace with a combination of filtered and opaque screen plantings (Figures 21 and 22, pages 72 and 74).
- Promote the retention of views into open space as Route 52 passes Winterthur, The Delaware Museum of Natural History, and The Methodist County House.
- Remove invasive plants on rights-of-way throughout this segment and develop long-term invasive plant management plans.
- Limit roadside signage to that consistent with the character of a rural byway.

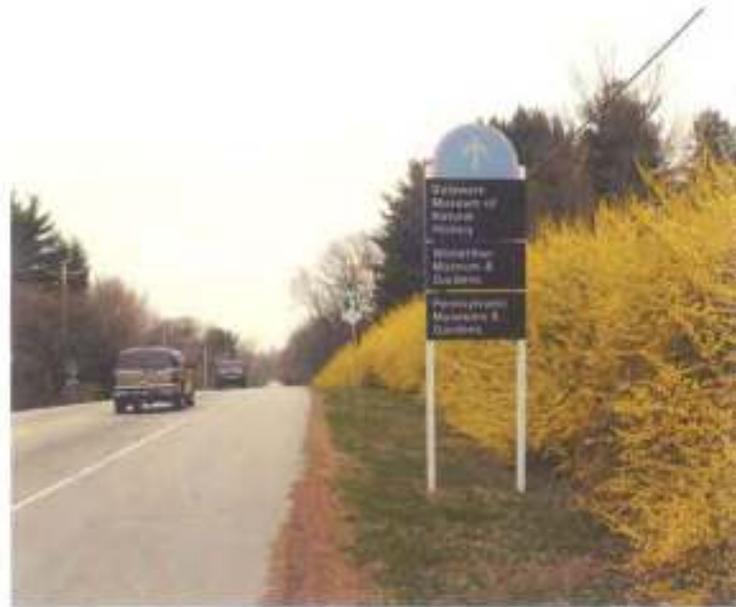
Plate 063
Forsythia hedge along Kennett Pike

Forsythia shrub rows are a frequent element along the Route 52 and Route 100 scenic byway. Perhaps overused, this perennially popular hedge has the advantage of being durable and noninvasive. The way-finding sign is typical of the style currently in use along the scenic byway and throughout the Delaware Valley (Plate 063).

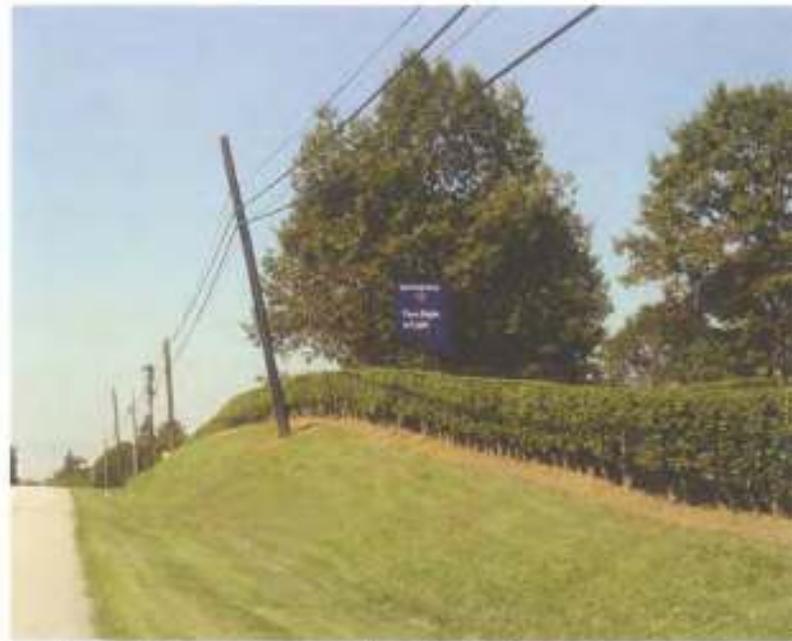
Plate 065 Osage orange hedge at Winterthur

The hedge that lines the Winterthur estate is pruned and clipped resulting in small leaves that look like privet. In fact, the hedge is comprised of osage orange, *Maclura pomifera*, a much coarser plant in its typical form and a plant that is rarely if ever used as hedging material (Plate 065). Due to its long tenure, this hedge is recognized as a venerable historic symbol of the estate.
