Scenic Stewardship:

A Plan to Preserve and Enhance the Landscape
of the Brandywine Valley Scenic Byway

Regional Landscape Enhancement
Susan Barton
Rick Darke
Gary Schwetz
For Delaware Greenways

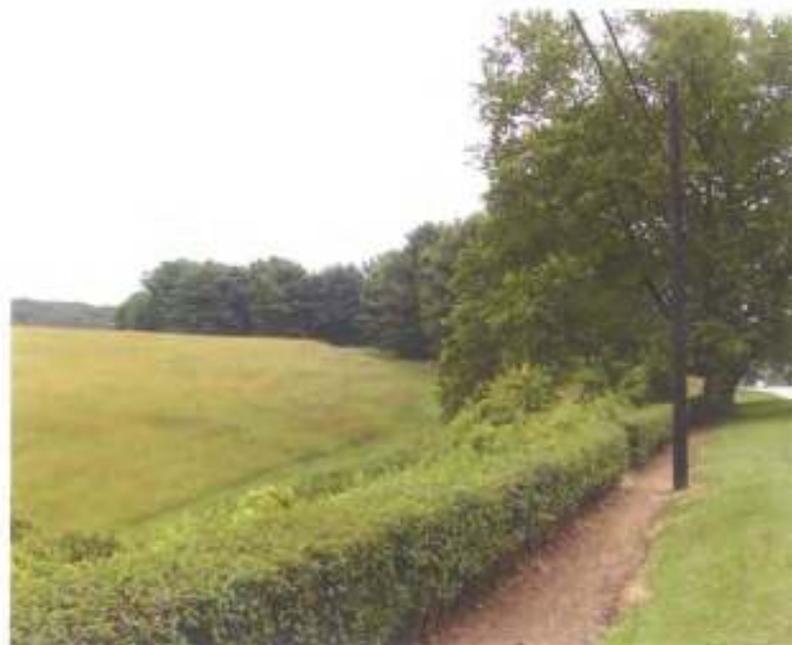
Plate 066 Winterthur estate meadow

Trees set in grasses maintained at meadow height contribute to the rural sense of Winterthur's peripheral landscape while the neatly mowed edge presents a carefully maintained look to passing motorists (Plate 066).

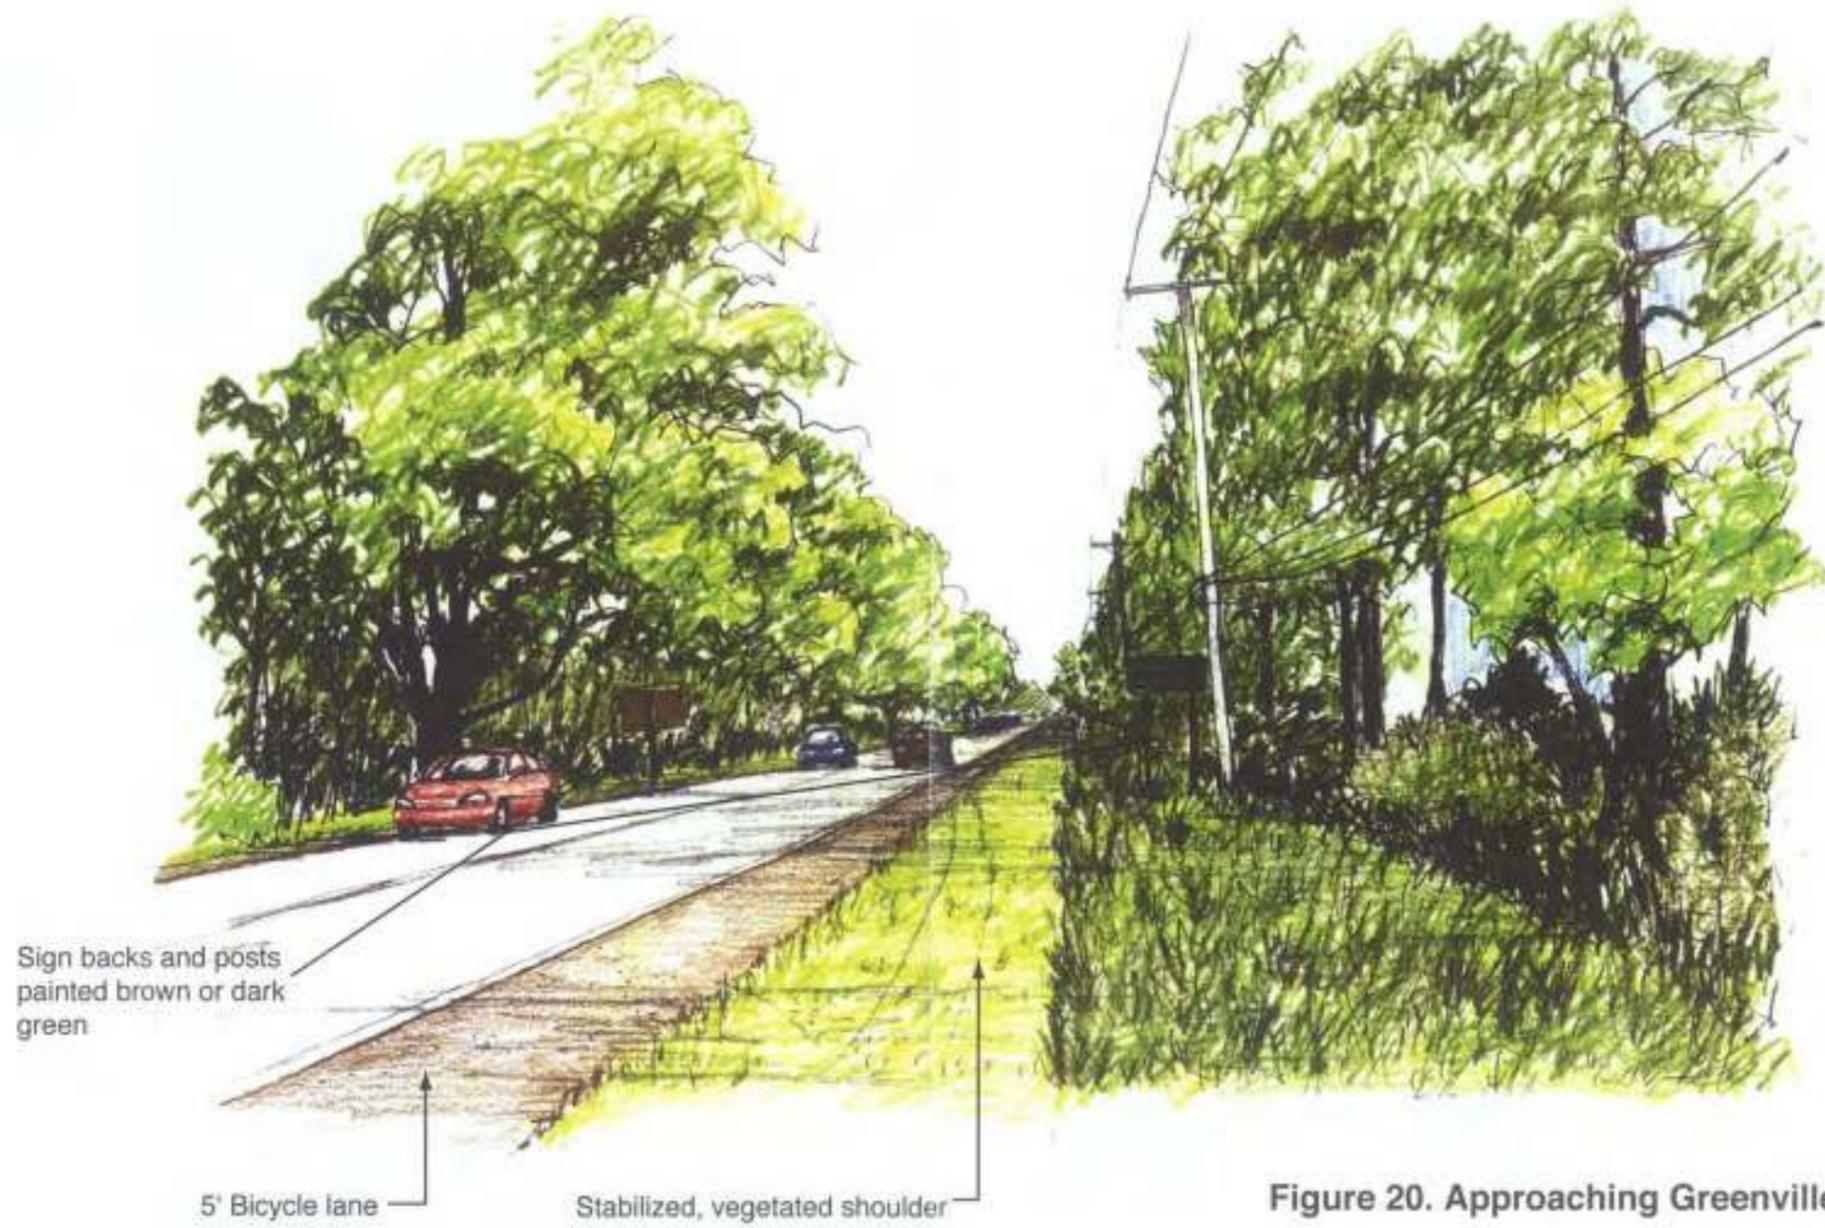
Figure 20. Approaching Greenville

Perspective

- Reduce road width and/or design plantings to create environments that alert drivers to the need for caution upon approach to Greenville (Figures 19, and 20, pages 71 and 72).
- Remove larch trees choked with invasive vines from Brook Valley Road to Campbell Road (Route 82) and replace with a combination of filtered and opaque screen plantings (Figures 21 and 22, pages 72 and 74).
- Promote the retention of views into open space as Route 52 passes Winterthur, The Delaware Museum of Natural History, and The Methodist County House.
- Remove invasive plants on rights-of-way throughout this segment and develop long-term invasive plant management plans.
- Limit roadside signage to that consistent with the character of a rural byway.

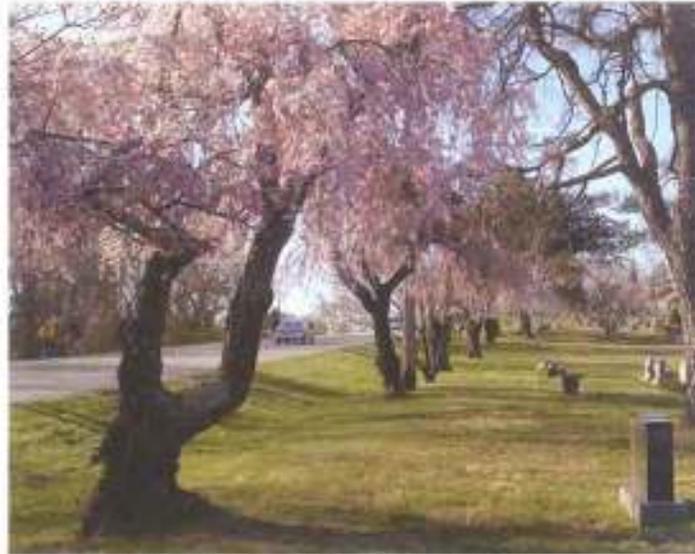
Plate 068. Historic weeping cherries at the Lower Brandywine Presbyterian Church cemetery

The Lower Brandywine Presbyterian Church cemetery is lined with a row of weeping cherries. This dramatic planting was identified as comprising a "high quality view" in the 1987 Brandywine Valley Scenic River and Highway Study. Although the trees are showing signs of decline, they have a number of years of useful life remaining (Plate 068).

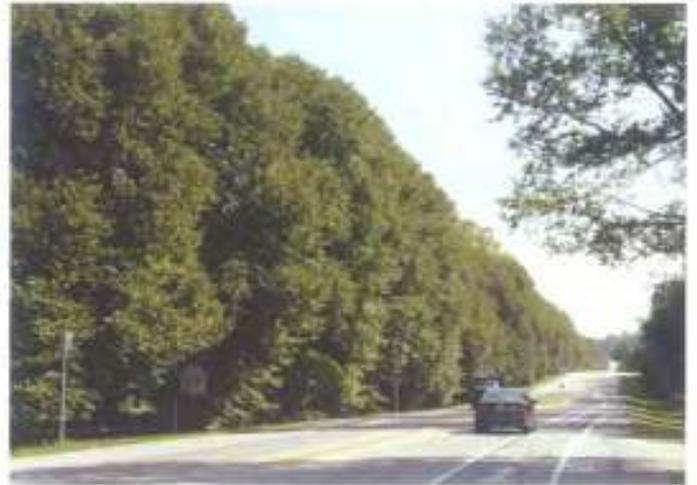
Plate 070
Linden trees on Kennett Pike

Judge Percy Nields' lindens, planted in the 1920's, (Plate 070) constitute one of the significant signatures of this section of scenic byway. Although the trees are currently in good health, the importance of this grand sweep warrants plans for their ultimate replacement. Private land owners are providing the necessary invasive plant control in some sections of this character segment (Plate 071).

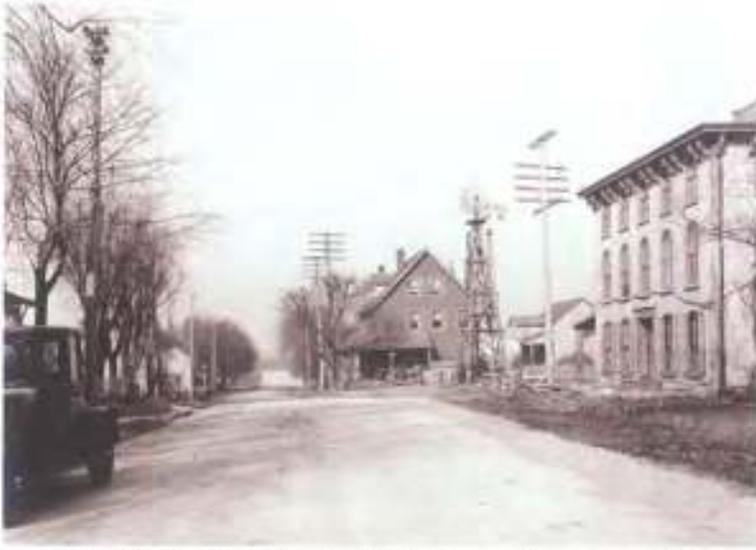
Plate 076 Kennett Pike through Centreville Village, ca. 1919

As documented in this 1919 photograph, overhead utility lines have been in conflict with Centreville street trees for nearly a century (Plate 076). As in Greenville, the aesthetic quality of the Village of Centreville would be greatly enhanced by placing utility lines underground. Freed from constraining overhead wires, tall-growing shade trees would develop natural form and mature size. The charm and tranquility of a canopy-covered street would help to restore the ambience of the village in a pre-electric age, and would lessen the impact of the widened roadway.

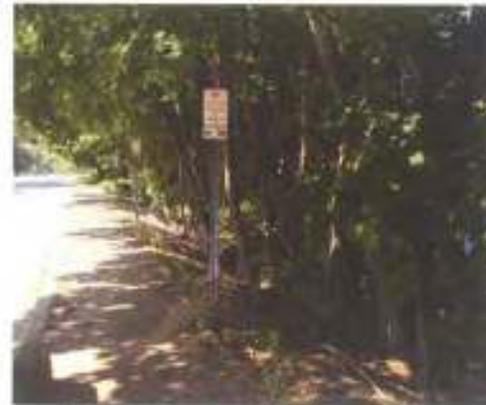
Plate 077
Norway maples on Centreville roadside

Although Norway maples have been planted as street trees since the earliest years of the village, time has proven them to be invasive exotics that have a detrimental effect on open spaces. They seed in densely and exclude other vegetation (Plate 077).

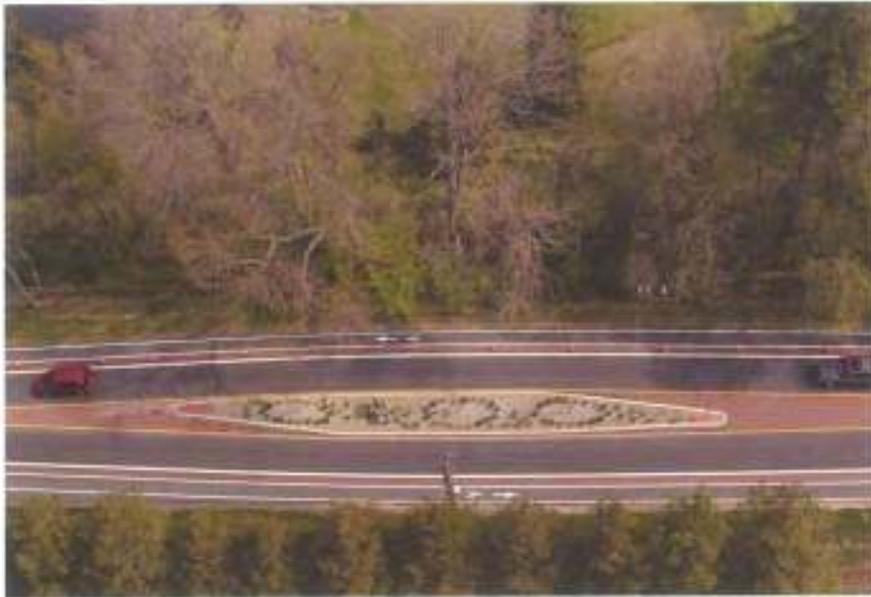
Plate 080 Gateway median

Gateway medians at the north and south end of the Village of Centreville were installed for traffic calming in early 2003. The minute scale and complexity of the median plantings is out of keeping with the larger scale and historic simplicity of a rural village (Plate 080). As currently planted, the medians are filled with pfitzer juniper and boxwood growing under zelkova trees. Many of the plants died through

the winter of 2003/2004 (Plate 081). Pfitzer junipers will grow too large for a small median planting and boxwood are not tolerant of the harsh conditions found in a roadside median. Zelkova trees are not in keeping with the historic tradition of Centreville. The medians should be planted simply.

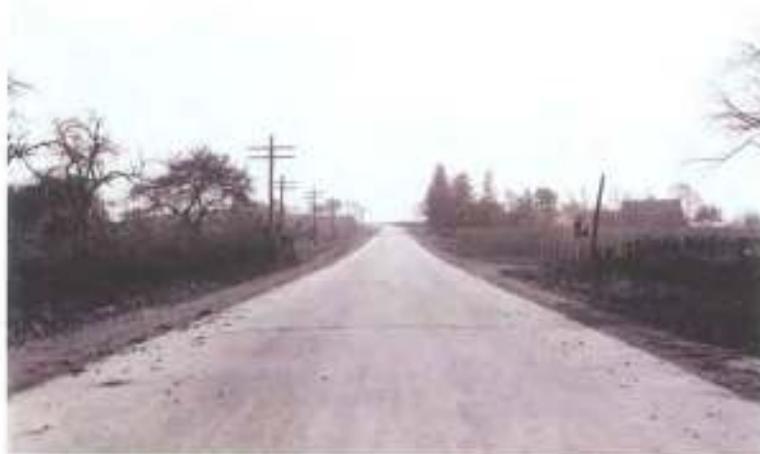
Plate 084 Kennett Pike south from the state line near the Line House, ca. 1919

Old fence lines marked with straight rows of wild cherries, locusts, multiflora rose, mulberry and honeysuckle are historic remnants. The true invasive threats in these fencerows should be identified and removed while the innocuous plants such as osage orange and wild cherry could be preserved as a desirable historical feature (Plate 084).

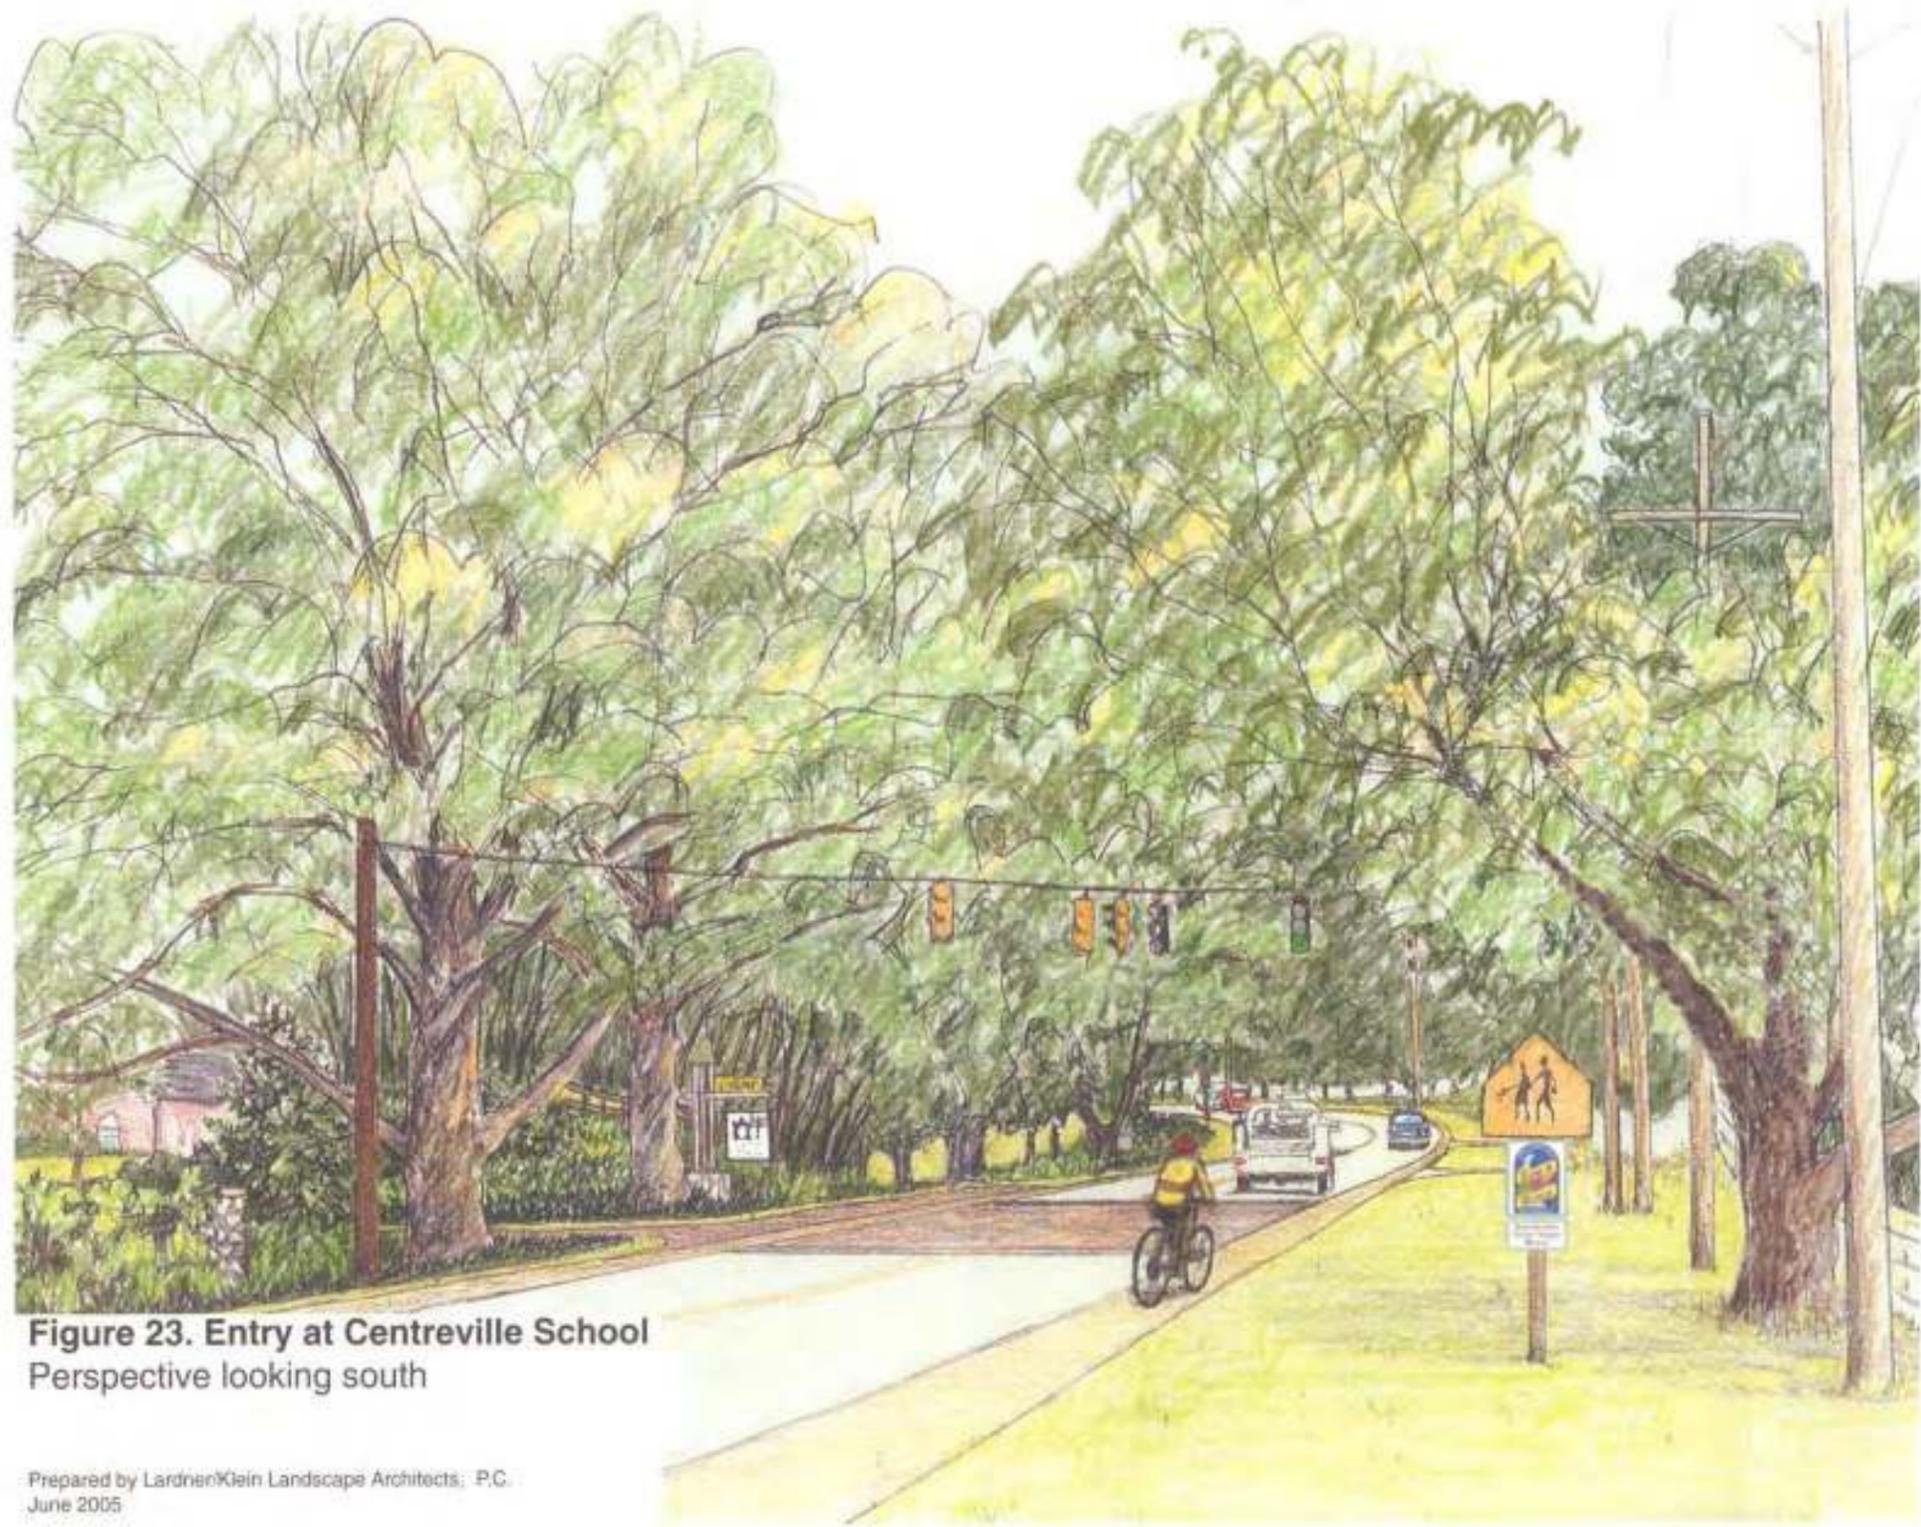
Figure 23. Entry at Centreville School
Perspective looking south

The Centreville School occupies a significant portion of the north end of this segment including a recent purchase of the nearby Line House, an 1800 historic tavern/inn built on the Pennsylvania-Delaware state line. Recent renovations to the entrance and parking for the Centreville School have included sensitive screen plantings, landscape berm construction and tree preservation while preserving open view's to the school's sheep pastures. Additional enhancements of the Centreville School properties such as entrance plantings, signage, invasive plant management, and screen plantings should be consistent with the character of the byway and was chosen as a model demonstration landscape project (Figure 23).

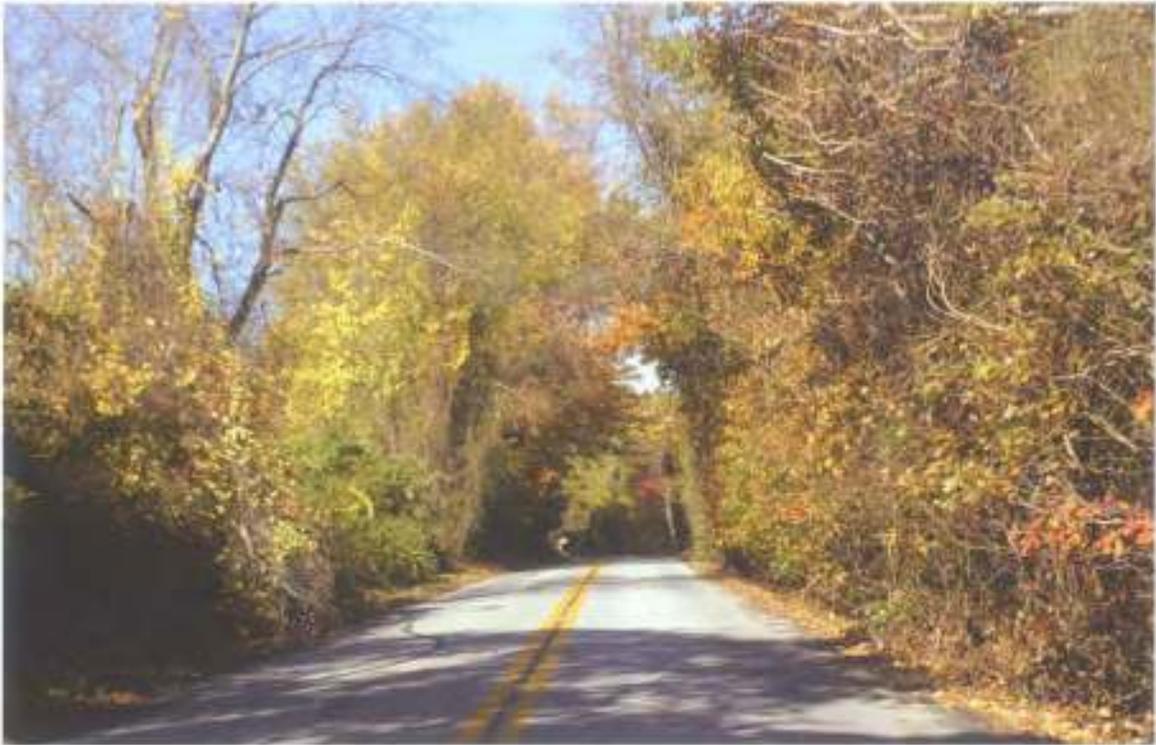
Plate 090 Section of Montchanin Road choked with invasive plants

This section of Montchanin Road runs through still-working farms, healthy forest regrowth and large lot residential properties (Plate 088, Plate 089). A portion of this segment is flanked by protected natural areas, such as the Flint Woods. Inaccessible sloping terrain has kept this land relatively undisturbed for over 150 years. Forest regrowth along parts of Route 100 occurred in an era without today's invasive exotic pressure, which is another reason why these forests are relatively healthy. More recent regrowth is often overgrown with invasive plant species, especially along sunny, disturbed edges. These plants often encroach upon the roadway (Plate 090).

- Remove invasive species (such as multiflora rose, honeysuckle, bittersweet, and autumn olive) that have grown up along the right-of-way on Montchanin Road and replace with appropriate plant species where needed to prevent erosion and sedimentation problems and regrowth of invasive species.

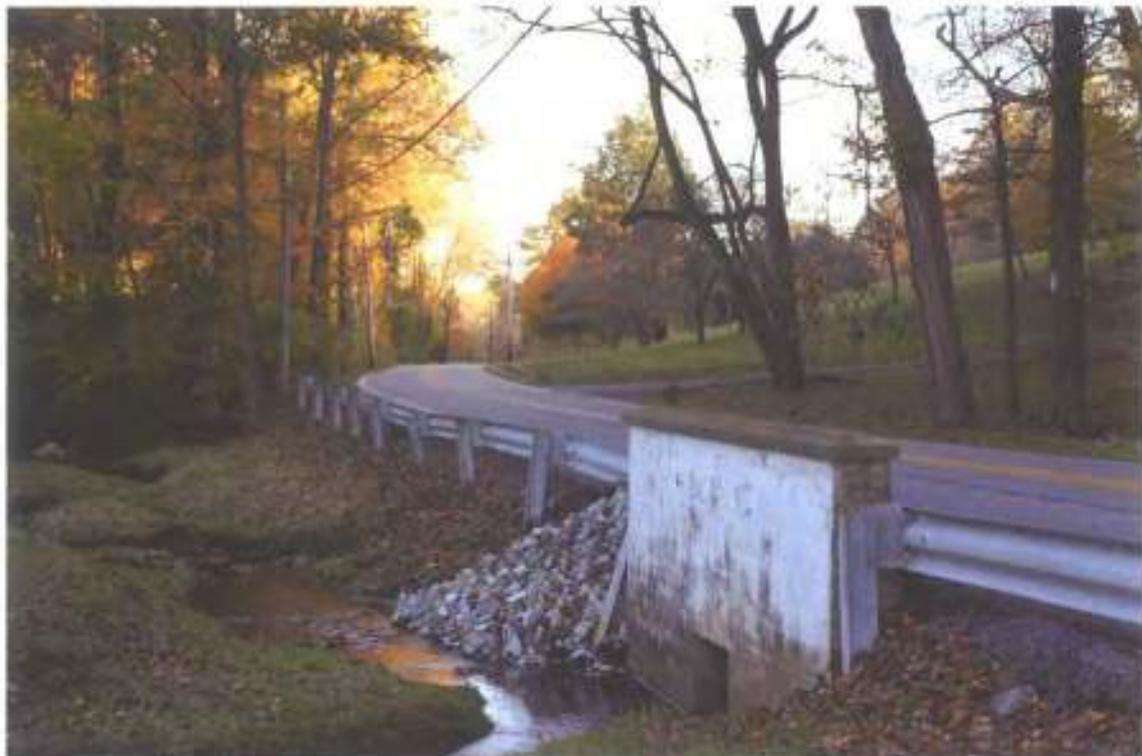
Plate 095 Opportunities for visual and environmental enhancements along Montchanin Road

A few negative features detract from the desirable character of the byway in this segment. A stream adjacent to the roadway, south of Center Meeting Road, is eroding due to lack of vegetation or other bank-stabilizing structure. Metal guardrail and ugly concrete bridge abutments mar the scenic beauty of the stream, adjacent pond and pastoral view shed (Plate 095).

- Explore sensitive solutions to erosion problems, such as on the stream bank adjacent to the roadway located 1/8th mile south of Center Meeting Road intersection (Figure 24). Use planting design appropriate for riparian buffers, while preserving the scenic view with low shrubs and herbaceous plants such as native sedges and rushes.
- Enhance the beauty of safety features along the roadway, such as replacing metal guardrail with attractive guardrail and adding a stone face on bridge abutments (Figure 24).

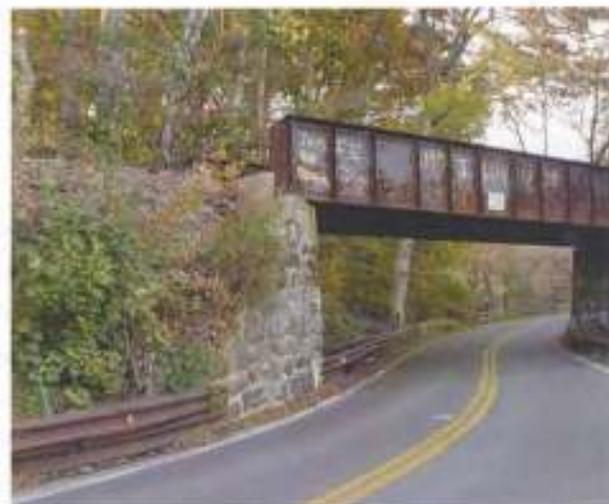
Plate 098 Wilmington and Northern railroad overpass

The Wilmington and Northern Railroad Bridge, while rusted and marked with graffiti, represents a significant historical feature of the roadway and serves to calm traffic (Plate 098). Grade level railroad crossings are an historical part of the Montchanin Road Scenic Byway as illustrated by this early 1900s photo of a crossing on Montchanin Road (Plate 099). Although the crossing has been modified, other grade level crossings remain in service, keeping up tradition and serving as traffic slowing devices (Plate 100, Plate 101). While attractive and historically significant, the railroad is another transportation corridor acting as a disseminator of invasives. That disturbance has resulted in a population of invasive plants requiring control to maintain the natural beauty of the corridor (Plate 102).

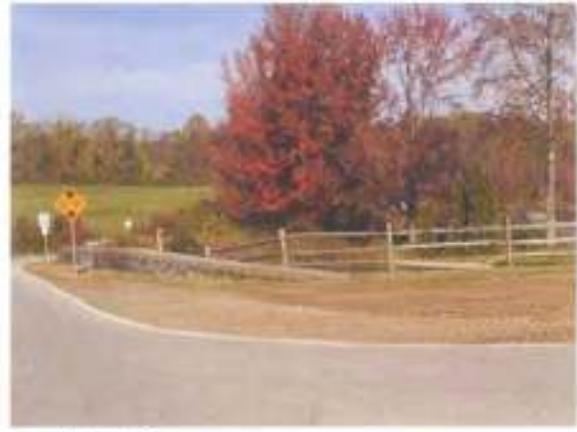
Plate 106
Shoulder at Montchanin Road / Route 92 intersection

Turf pavers were added to this intersection with the intent to provide safe traversable shoulder spaces while maintaining a narrow look and feel. Turf is not currently growing in these pavers. It is possible that the turf pavers were not installed properly (Plate 106). A proliferation of road signs detracts from the scenic viewshed (Plate 103).

- Investigate alternatives to existing turf pavers at Montchanin, Adam's Dam and Thompson Bridge roads to achieve the look of a small scale, narrow intersection (Figure 25).
- Screen rubble mound by removing invasive species and planting a mixture of tall-growing shade trees and eastern red cedars well beyond utility lines.
- Consolidate highway signage at intersection of Rt. 100 and 92 (see Plate 103).

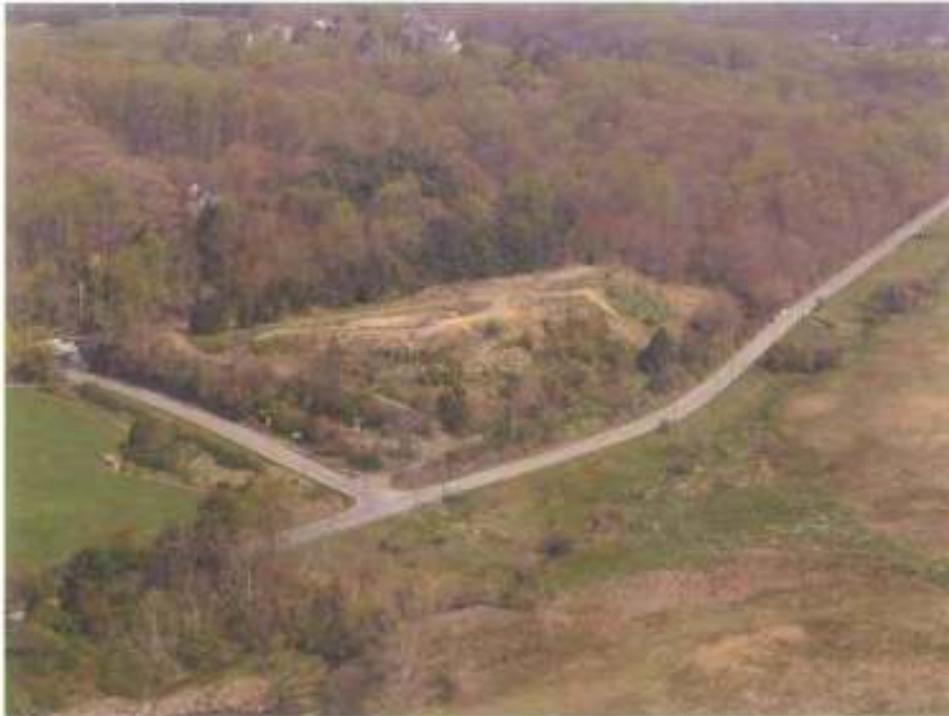
Plate 107. Rubble mound from the air

A huge rubble mound dominates the northeast corner of the northern intersection of Adam's Dam and Montchanin roads. Invasive plants partially screen this artificially created, undesirable element (Plate 107).

- Keep existing woodland edge close to the road (without shoulders) to maintain the meandering rural character of the byway.
- Plan drainage solutions to preserve the character of the roadway; seek alternatives to unsightly rip-rap.
- Identify and screen undesirable views (such as rubble mound, see Plate 107); keep desirable views open and framed.
- Keep new plantings consistent with the rural character of this section of the Scenic Byway landscape.
- Design development entrances to respect the character of the byway working with a scale and a palette of materials appropriate for a rural, agrarian corridor in this region.
- Limit roadside signage to that consistent with the character of a rural byway.

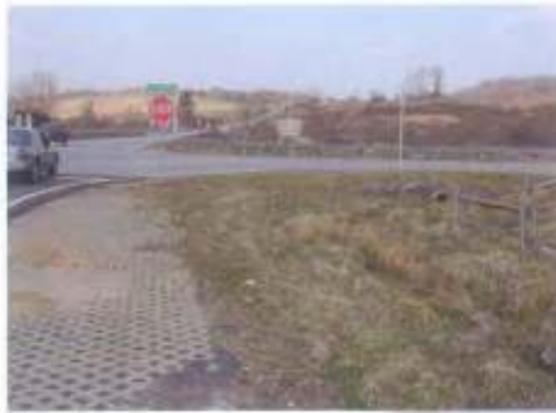
View of existing shoulders

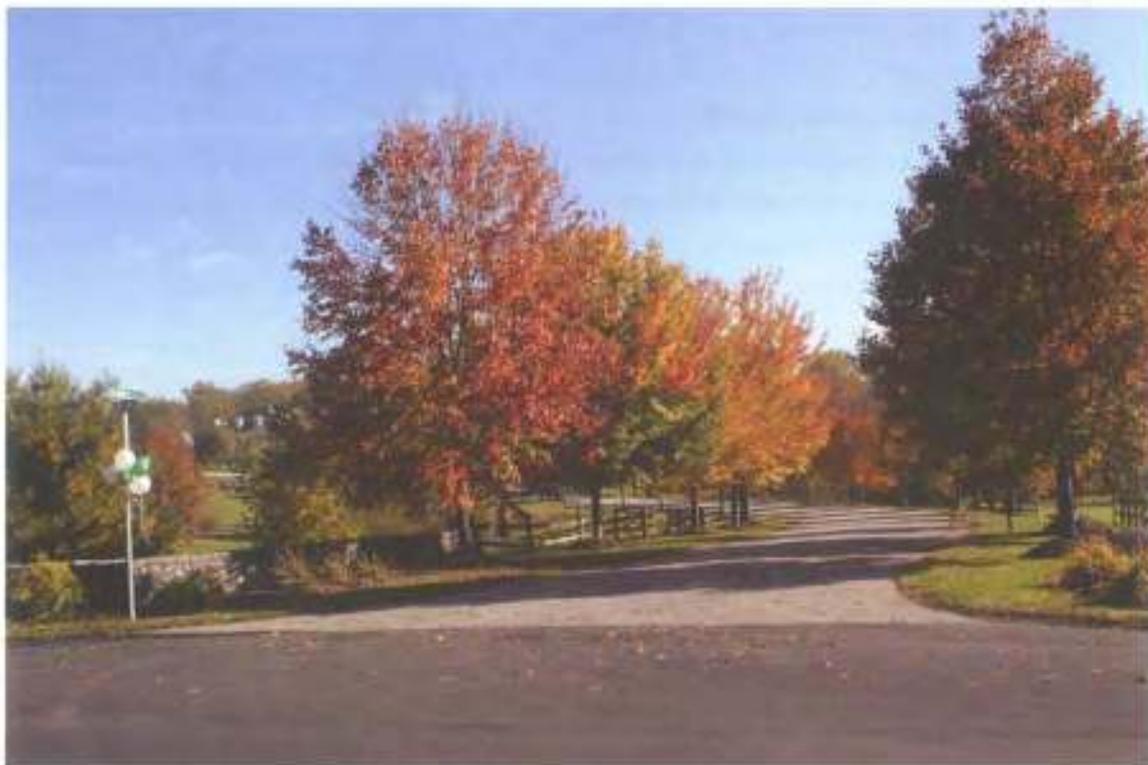
Plate 110 Entrance to Stoney Run development from Montchanin Road

Historically, trees lining roadway sections and private lanes exhibited considerable diversity, as can be seen in this 1870 image of DuPont's Lane (now Buck Road) (Plate 109). Respecting this tradition, Summit Lane, the entrance road to Stoney Run development, has been planted with seedling red maples. The trees have a variety of habits and colors resulting in greater diversity, both visual and biological, than would result from a uniform planting of a cultivar such as 'Red Sunset' or 'October Glory' (Plate 110).

- Design plantings at development entrances to be consistent with the simplicity and historical character of the byway (see Plate 110).
- Plant tall-growing shade trees that provide enclosure yet preserve vistas, as new developments are built along Montchanin Road.

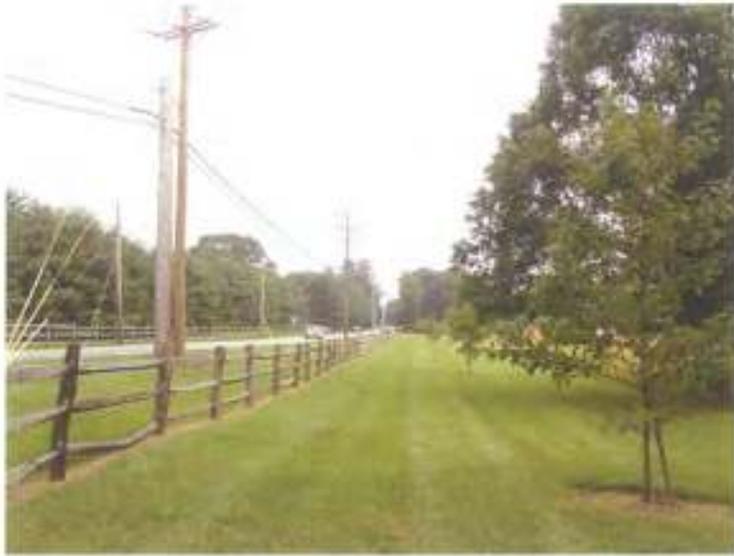
Plate 111
Dense evergreen screen (on left) along Montchanin Road

If both sides of the Montchanin Road byway were screened with evergreen trees (as visible on the left, Plate 111), the experience would be uninteresting and somewhat claustrophobic. Deciduous trees, especially if limbed high, offer a creative alternative. They preserve vistas for travelers yet provide a sense of enclosure and privacy for residential landowners (Plate 112).

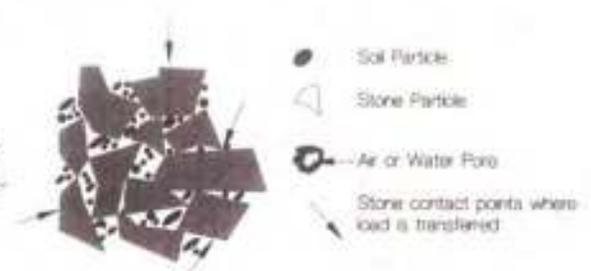
'Structural soil' is a designed medium which can meet or exceed pavement design and installation requirements while remaining root penetrable and supportive of tree growth. Cornell's Urban Horticulture Institute, has been testing a series of materials over the past five years focused on characterizing their engineering as well as horticultural properties. The materials tested are gap-graded gravels which are made up of crushed stone, clay loam, and a hydrogel stabilizing agent. The materials can be compacted to meet all relevant pavement design requirements yet allow for sustainable root growth. The new system essentially forms a rigid, load-bearing stone lattice and partially fills the lattice voids with soil (Figure 1). Structural soil provides a continuous base course under pavements while

Fig. 1: The stone lattice bears loading while the soil particle partially fills the lattice voids.

providing a material for tree root growth. This shifts designing away from individual tree pits to an integrated, root penetrable, high-strength pavement system.
